Po Shan Catchment

土木工程拓展署
Civil Engineering and
Development Department

Quantitative Risk Assessment

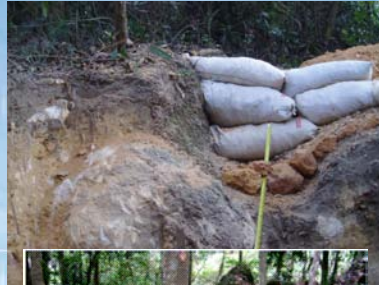
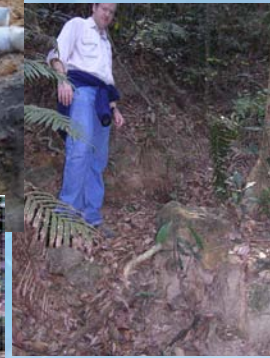
Geology

- Colluvium (20m max.) overlying weathering profile of volcanic bedrock (30m max.) in lower portion of the site
- Saprolite and rock exposures predominate over upper portion of site above line of rock cliffs
- Two classes of colluvium: older deposit that has weathered insitu and younger deposit with higher proportion of coarse clasts and boulders
- Rockfall debris below rock cliffs

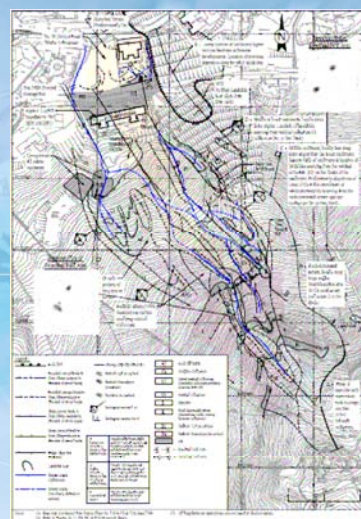
Geomorphology

- Catchment defined by divergent spur ridges
- Poorly defined drainage lines within
- Two lines of rock cliffs
- Elongate debris lobes below rock cliffs
- Relict landslide scars along flanks

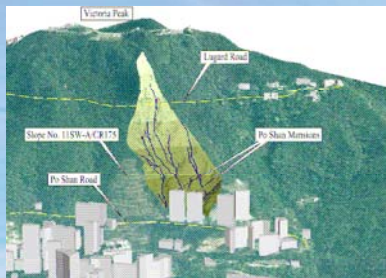
Hazard identification and hazard model

- **Landslide Hazards**
 - Type I: Shallow retrogression in old colluvium, E & W flanks
 - Type II: Shallow debris slides in upper portion of catchment
 - Type III: Rock slides on the rock cliffs
 - Type IV: Deep-seated failures in old colluvium & saprolite
- **Types I & III dominant**
