# APEC Seminar on the State-of-the-Practice of Deep Excavation Works in Malaysia, Taiwan and Hong Kong

21<sup>st</sup> May, 2011

**The State-of-the-Practice of Deep Excavation Works in  
Malaysia, Taiwan and Hong Kong**

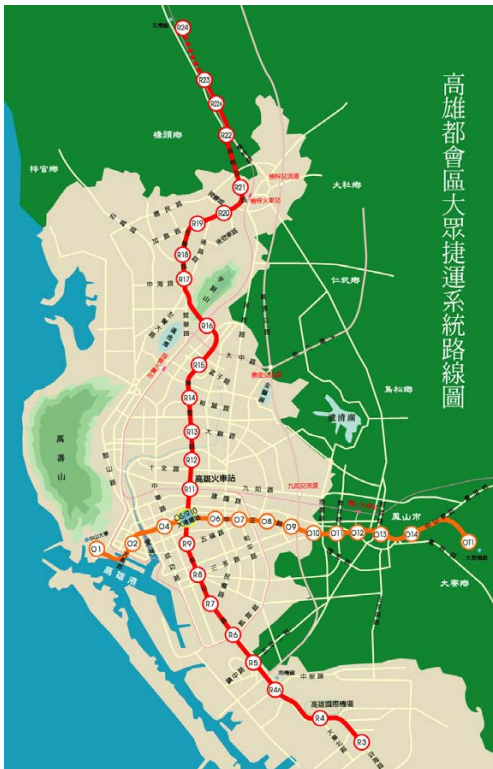
Figure 1.1: Road map for the Kaohsiung MRT system

This project works by turnkey contract (Design and Construction merger contract), and BOT mode (Built, Operate, Transfer: by private enterprises construction and operation of a facility, after a certain period and then transferred to the central or local government) (Figure 1.1 Kaohsiung rapid transit system of the road map).

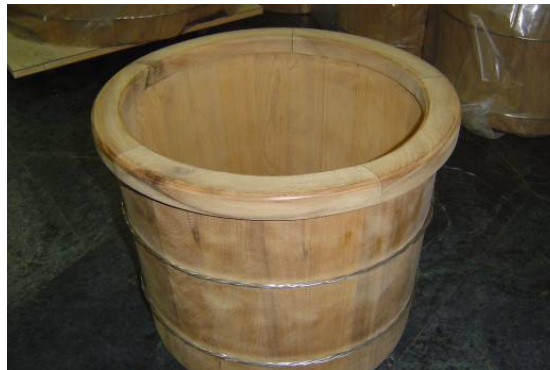
Photo 3.1: A cypress wood barrels

The design concept of the circular diaphragm wall, as simple in principle as shown in the Photo 3.1 of a cypress wood barrels. Cypress wood barrels are after the rectangular cypress wood piceses chips into doughnut-shaped, in its upper and middle to wooden boxes and wires tightly bundled like a scarf. Cypress wood swelling with water, but wooden frames and wire binding the axial compression force for a unit circle direction caused, that is, pre-force involvement, internal are not filled with water to form even to loose solid structure.

- (1) The use of "Hoop Compression effect" (organized by the circumferential direction of axis pressure suppression of diaphragm wall by bending tensile stress)
- (2) The use of "Ring Stiffness effect" (produced by circle shape the toughening of retaining rigid to inhibit deformation of diaphragm wall and surrounding land subsidence), making excavation work in no lateral supporting under the condition also can significantly enhance the efficiency of excavation and building construction.

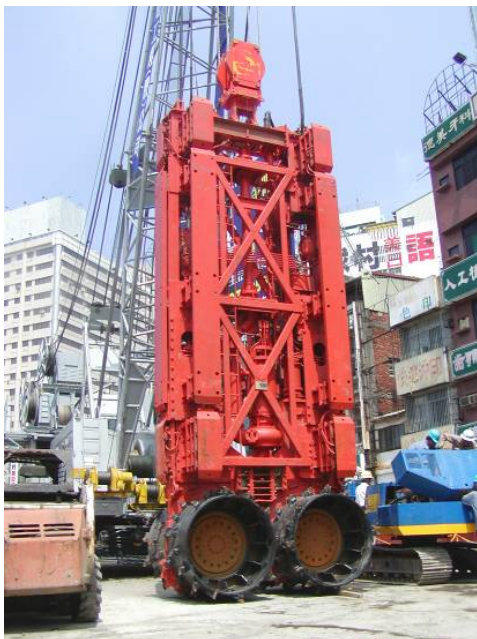
Photo 4.1: EMX-150 excavator

As noted above, this works by the use of a "construction method of concrete cutting joint", specifically called from Japan the horizontal axis of Rotary excavator for the construction of the circular diaphragm wall. In line with the circular shape of diaphragm wall (140m of inner diameter and wall thickness 1.8m) in the machine selection original consider EMX (ERECTRO-MILL EXTRA-150) (standard thickness 650~1,500mm construction, excavation wide 3,200mmx146 unit) and EMX-240 (1,200~2,400mm wall thickness of standard construction, excavation wide 2,400mmx196 unit) of two models. But consider cutting concrete may cause mechanical failures, even affecting the duration, so decided on a smaller unit number programmes, Two excavators will be modified into the corresponding 1,800mm of wall thickness, construction of 146 units (Photos 4.1 EMX-150 excavator).

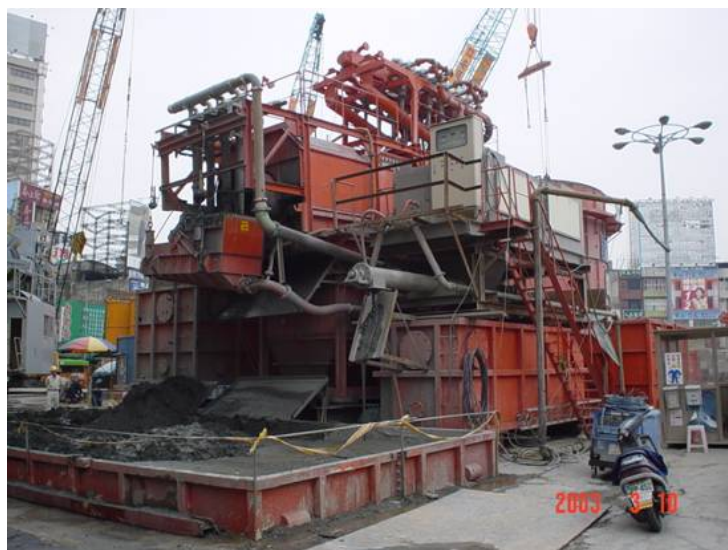
Photo 4.3: Soil-water separators

To ensure the quality of concrete of the diaphragm wall, stabilizer quality management is important. Using larger density in a diaphragm wall for the trench excavation stability. Before placing reinforcement cage to trench, should replace all stabilizer with a low density, rare sand composition of stable liquid (benign liquid), implementation of the so-called "benign liquid replacement". In other words, the stability of liquid quality management into "the excavation of diaphragm wall" and "before the concrete setting" two-stage, in order to implement diaphragm wall construction safety management and quality management.

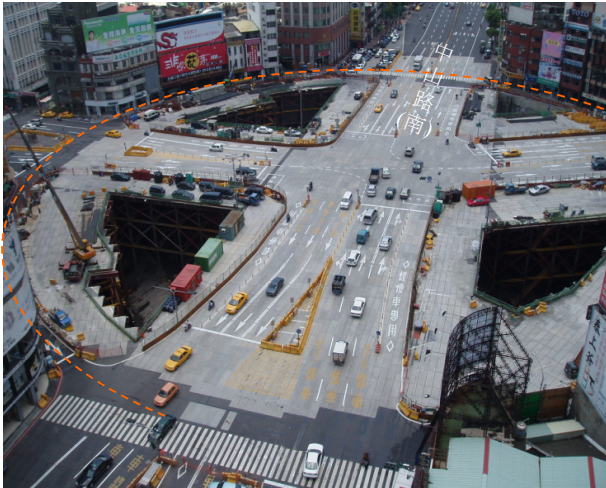
Figure 5.1: Status of the internal circular excavation

Photos 5.1~5.3 show the internal excavation phases. The excavation of the final outsole period at the end (2004 ~ August) due to Typhoon rainfall and other factors, caused drainage treatment is difficult, but luckily at the end of August, the successful completion of excavation and PC set.

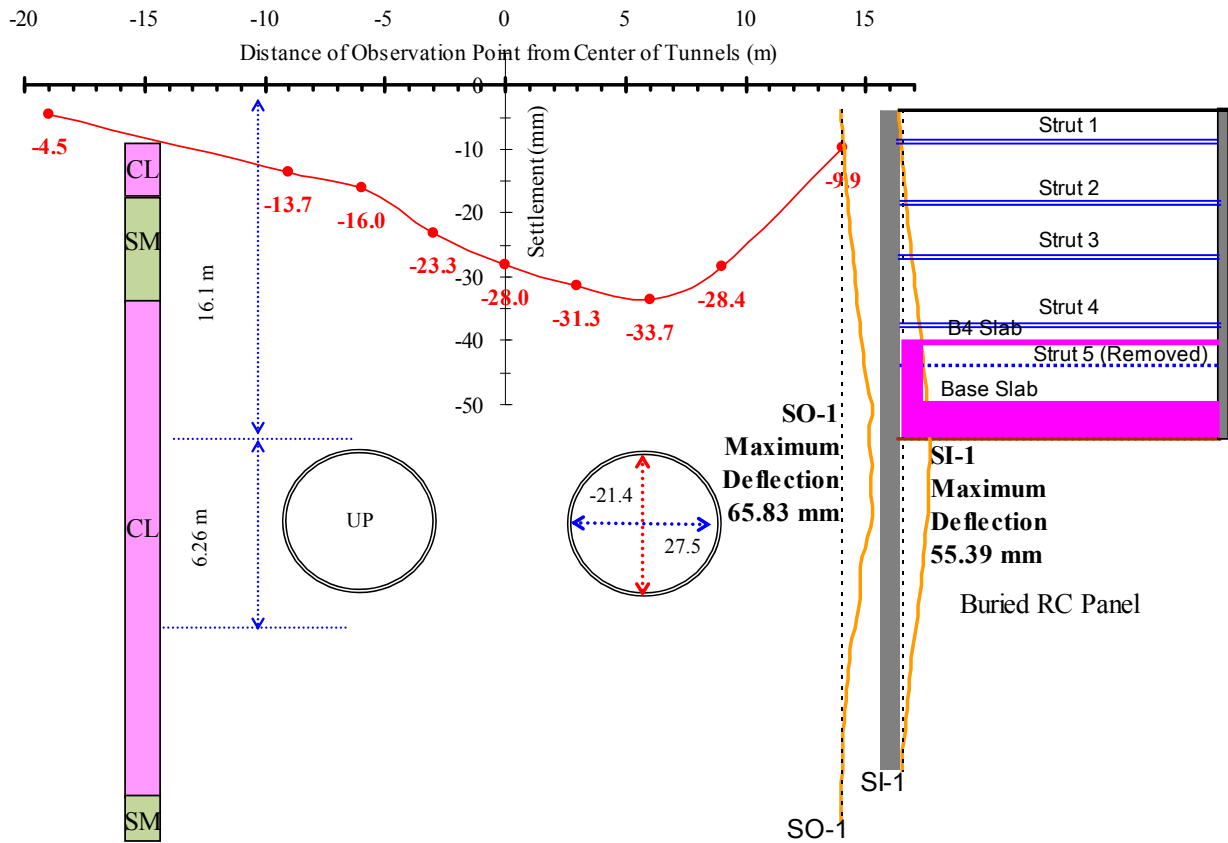
Figure 11: Ground settlement and lateral deflection of ground and wall at the construction of B4 slab

Figure 11 further shows the corresponding ground settlement and lateral deflection of ground and diaphragm wall measured at the construction of B4 slab. From the figure, the maximum settlement and wall deflection are on the order of 34mm and 55mm, respectively, at the time when maximum horizontal convergence (27.5mm) is detected. By checking the centerline coordinates for the down-track tunnel, shows substantial latitude deviation, with a maximum of about 45mm, to the south within the range of excavation site. Such a result implies excavation effects on the down-track tunnel.

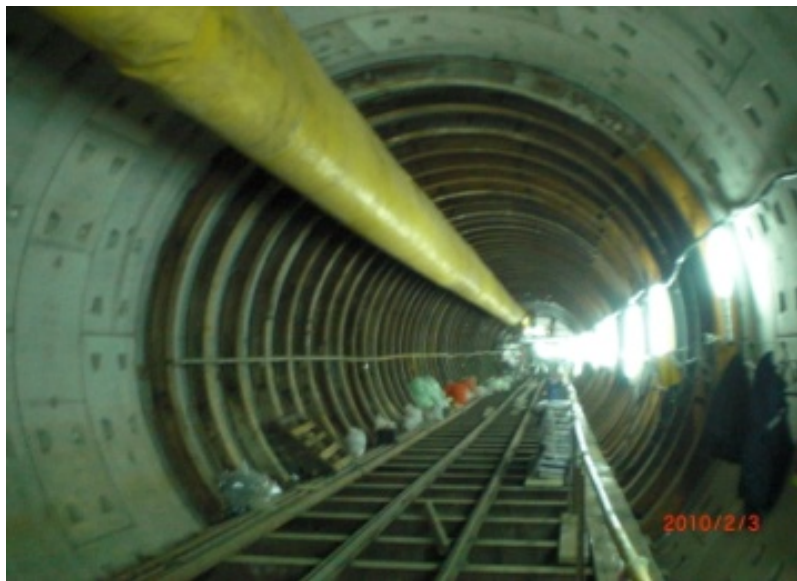
Plate 1: Tunnel propped with steel frames

- (1) Steel frames propped for the section of substantial deviation (Figure 12 and Plate 1).
- (2) Additional instruments installed to monitor subsequent variation of convergences and cracks on the linings (Figure 9 and Plate 2).
- (3) Frequency of monitoring increased to twice a day after the occurrence of excessive convergence, dropped to once in two to three days as convergence becomes stable, and increased to once a day as the up-track tunneling passes by.
- (4) Speed for up-track tunneling dropped to 8m a day for the range of excavation site.
- (5) Addition of reshoring for the excavation site.

In response to the excessive convergence observed at Ring 134, several protection and mitigation measures are implemented, including:

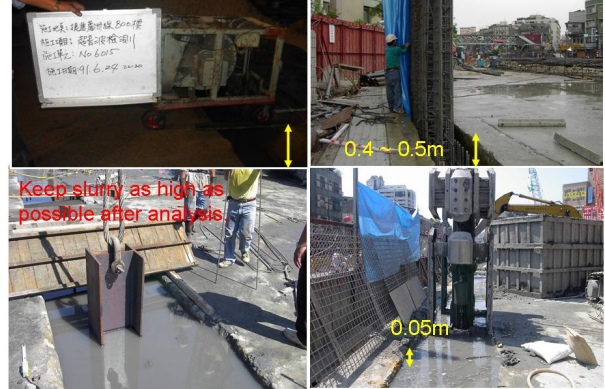
Figure 3-7: Slurry raise from 0.4m to 0.05m below guide wall surface for O47 station.

Serious diaphragm wall trench collapses occurred during construction of O47 station, while for O46 station, the diaphragm wall installation proceeded smoothly despite applying the same basic counter measures. Even though the ground condition of O46 station is similar to the ground of O47 station (refer to Table 3-3), the ground water table is 1.8m and 1.0m below the ground surface for O46 station and O47 station, respectively (refer to Figures 3-4 and 3-5). In general, the slurry was controlled at around 0.4m below the guide wall (ground) surface in order to prevent slurry to flow through and pollute the nearby roads for normal operation (refer to Figure 3-6). As a result, the 1.4m (=1.8m-0.4m) different pressure head between slurry and ground water is kept for O46 Station. On the other hand, there is a different pressure head between slurry and ground water of 0.6m (=1.0m-0.4m) for O47 Station (refer to Figures 3-5 and 3-7).

A trench stable analysis model (refer Figure 3-8) was introduced to analyze the safety factor of excavation trench affected by ground and slurry condition for the project. The analysis (refer to Figure 3-9) shows that the different pressure heads between the slurry and ground water was significantly affecting the safety factor of trench stability. So, keeping the different pressure heads between the slurry and ground water table as high as possible will be a major and economical counter measure to prevent trench failure (refer to Figure 3-7).

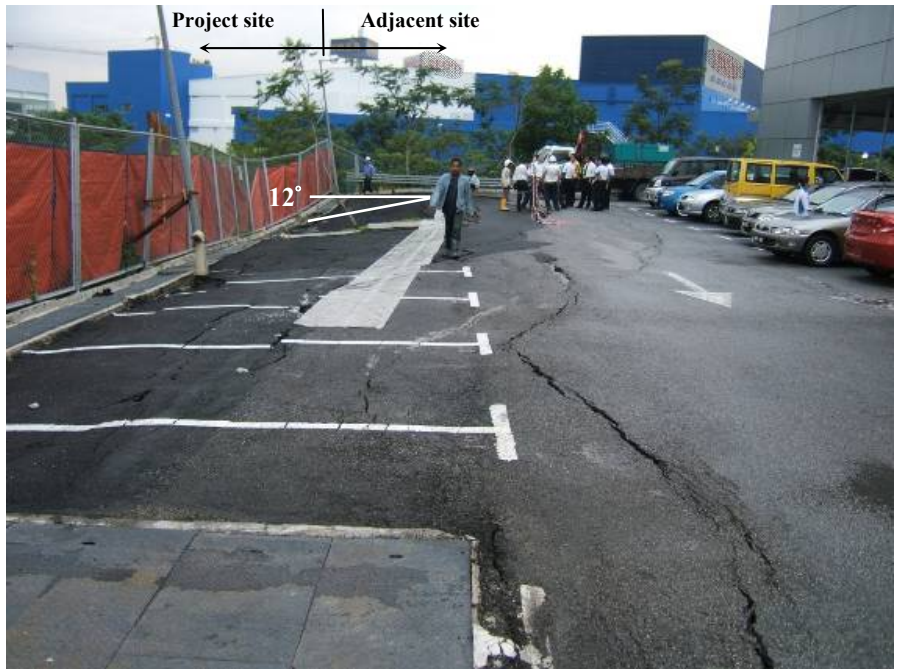
Figure 6: Site conditions of adjacent lot after the incidence of wall movement and ground distresses (Southward view)

It was observed that continuous tension cracks appeared at varying distance away along the sheet pile wall of approximately 73m long. The tension cracks were more distant away from the sheet pile wall at the southern end and became closer to the sheet pile walls toward northern end. At the time of inspection, more extensive excavation was carried out at the southern portion than the northern portion. The platform for the backyard car park of the adjacent lot had shown ground subsidence with tension cracks as shown in Figure 6 and Figure 7.

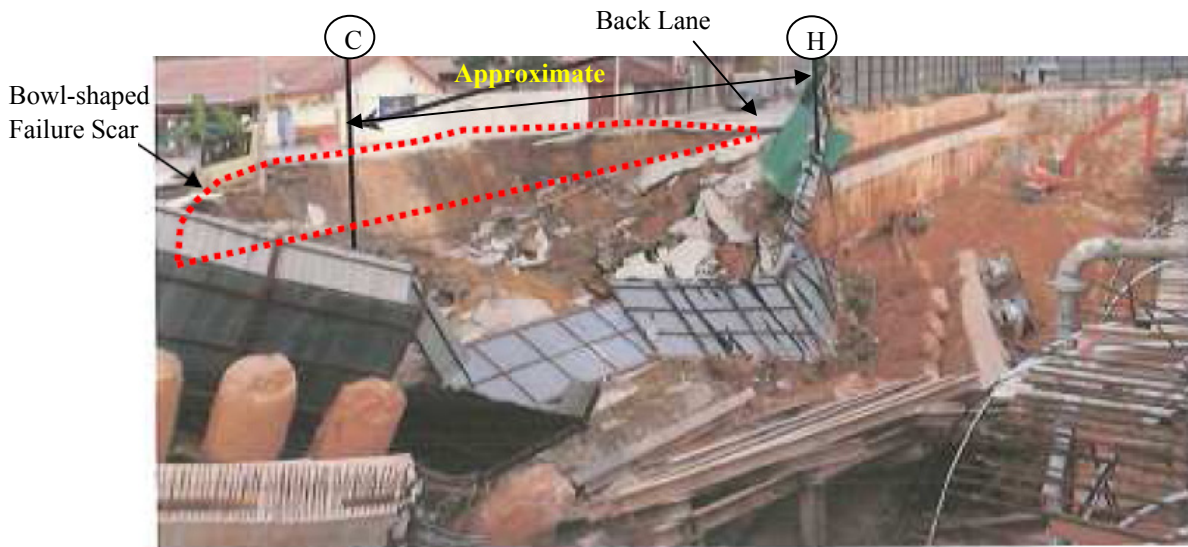
This case history involved construction of two-level basement in city area using CBP wall with temporary strutting. About 40m stretch of CBP wall collapsed, after the water pipe burst incident at the back lane reported 3 hours ago as shown in Figure 14.

Figure 14: Collapsed CBP between Gridlines C and H

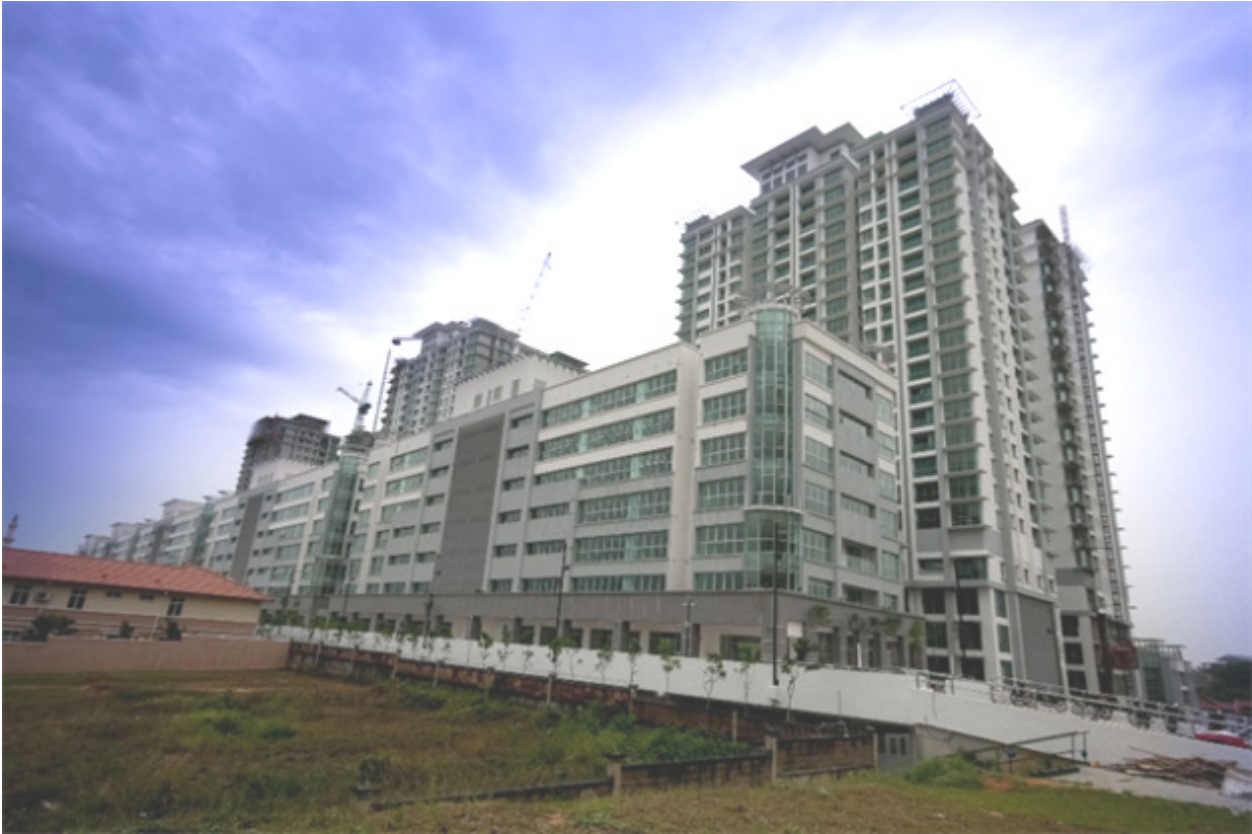
Figure 3: Completed basement and superstructure works.

The proposed development, Solaris Dutamas, consists of 3-5 storey commercial units, office blocks of up to 42 storey high and 33-storey service apartments with 6 levels of basement on an 18-acres land. Figure 2 shows picture of the proposed development while Figure 3 shows completed view of the basement works taken recently (superstructure works completed).

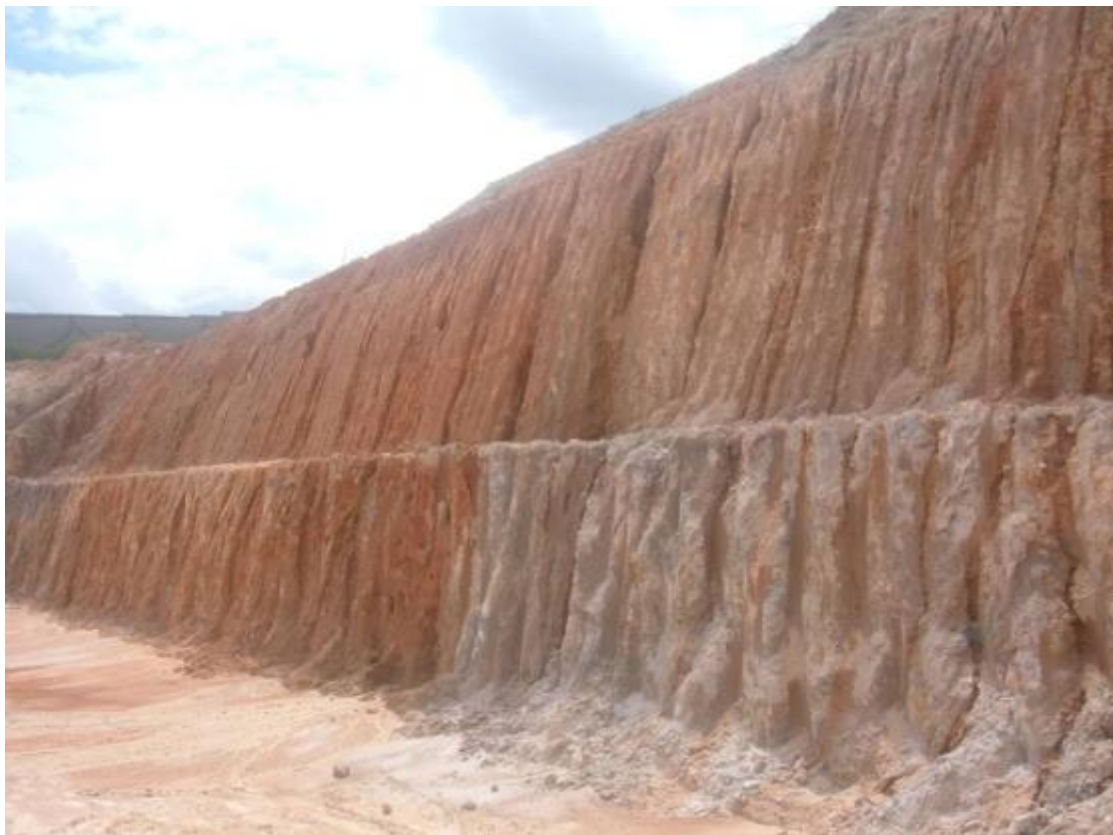
Figure 5: Typical weathered metasedimentary materials exposed during soil nail construction (Grade V/VI).

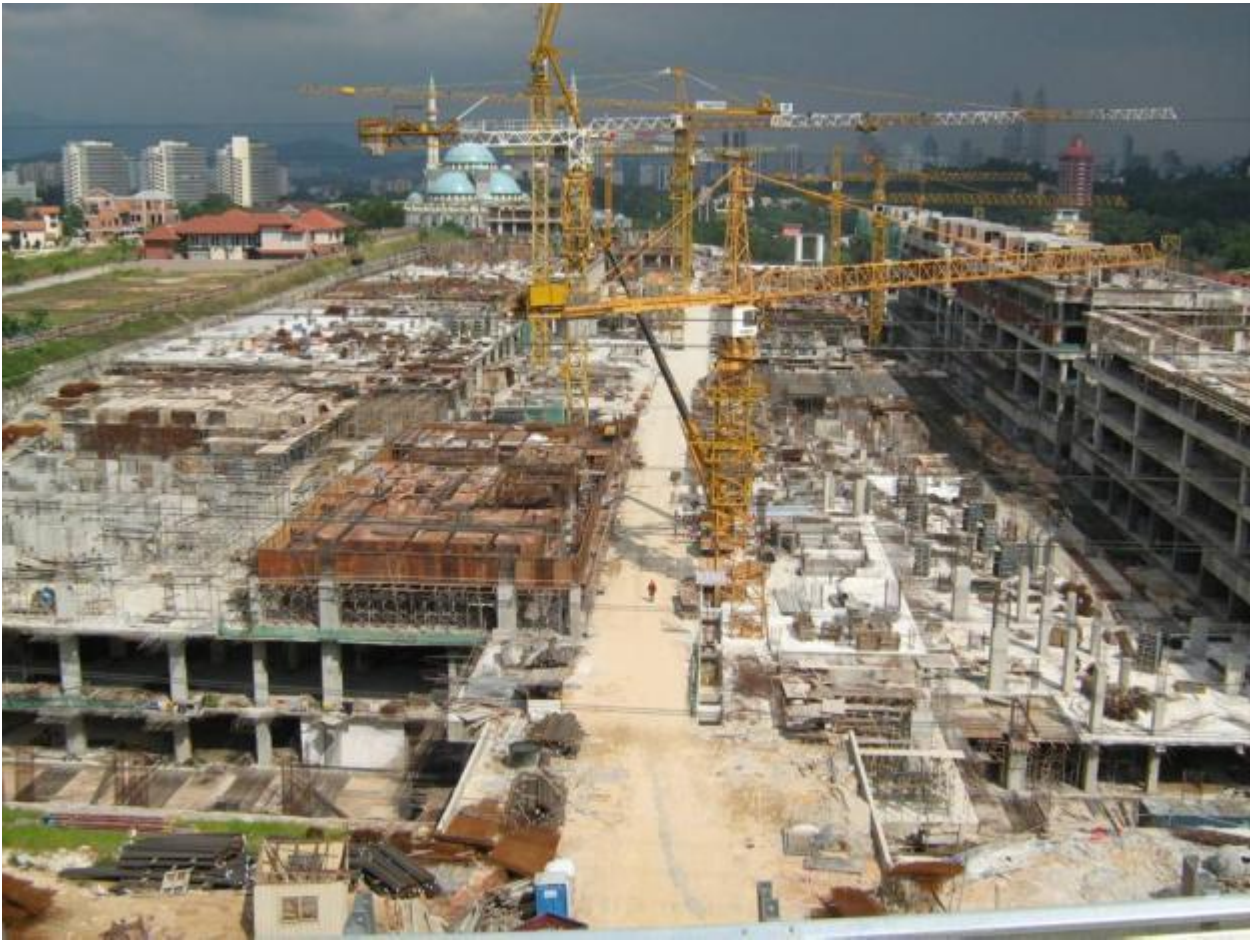
Figure 11: Picture taken after completion of basement construction.

Figure 8 shows the alternative soil nail system which was successfully constructed. The alternative soil nail system requires some minor modifications to the basement layout and also proper planning of construction sequence and foundation system to support the superstructure. Figures 9 and 10 show pictures taken during soil nail construction where the close proximity of existing buildings (less than 5m) to the soil nail slope can be observed. Completed bored piles (with protruding starter bars) within the soil nail slope can also be seen. Figure 11 shows picture taken when basement construction has been completed.

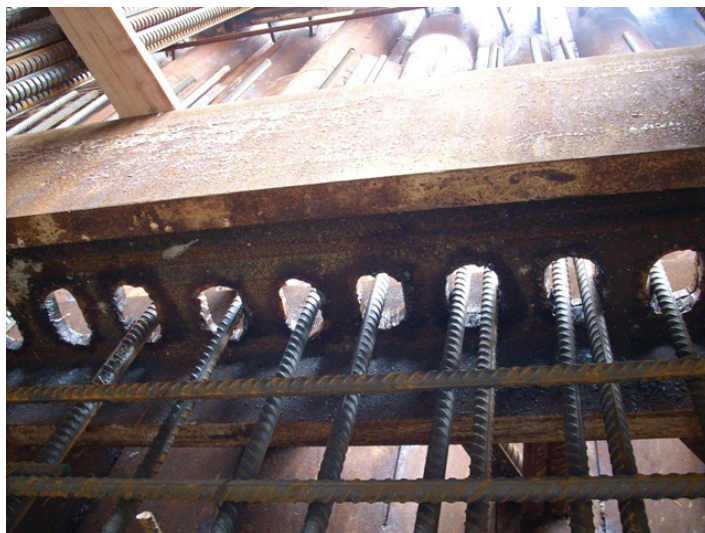
It is common that architectural changes in the layouts of underground structures occur after the installation of the temporary earthwork supports. This can result in positional clashes that are often remedied on site by *ad hoc* modifications to the temporary works. Building Information Modelling (BIM) can be used for the early detection and designing-out of clashes, allowing construction to proceed in a more controlled, planned and therefore safe manner (Figure 3).

Plate 3: Clash between temporary and permanent works

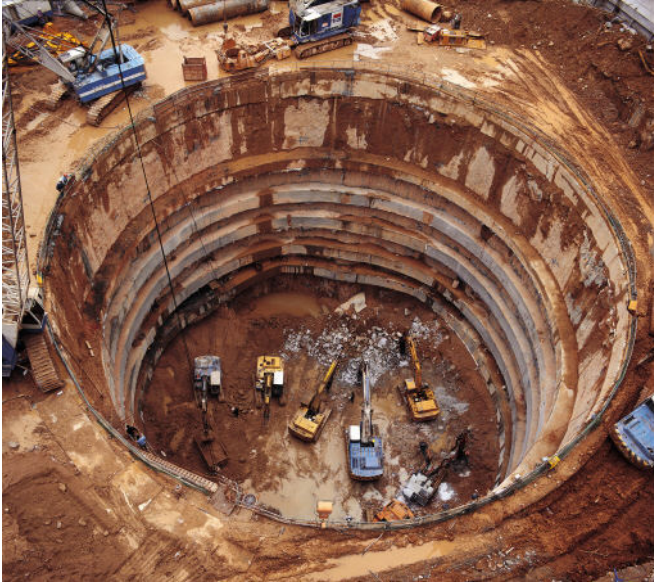
The Cheong Kong Center made use of a 1.2m thick circular diaphragm wall for the excavation to be progressed for the main core of this 62 storey building. The internal diameter of the shaft was 37m and the depth of excavation was 28m. It should be noted that rock was at the base of the excavation and the core of the building was founded on a large pad footing at the base of the excavation. Plate 1 shows an image of excavation when it was near completion in late 1997. There was a 1m deep capping beam constructed at the top of the diaphragm wall panels and it can be seen towards the base of the excavation that there were a series of ring beams all about 1m high by about 1m thick.

Plate 1: View into the excavation for the core of the Cheung Kong Centre

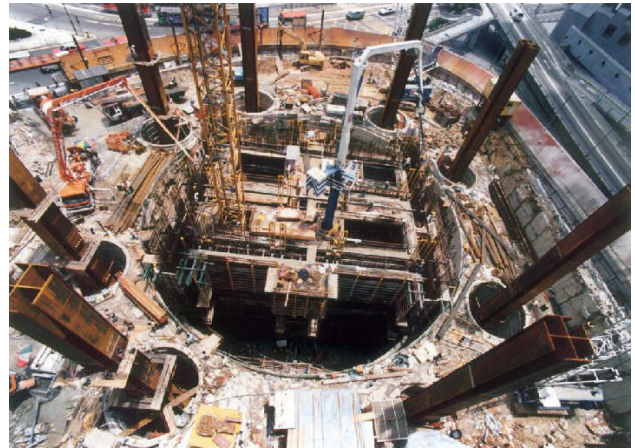
While the core could be constructed within the circular excavation the surrounding mega columns were each founded within their own 4m diameter machine dug caisson to enable 7m diameter circular footings to be founded onto rock as shown in Plate 2. It should also be noted that there was also a 1.2m thick perimeter diaphragm wall to support the overall basement that was formed later in the project. This meant that the circular diaphragm wall was completely removed as part as the basement was subsequently excavated.

Plate 2: View of the core and mega columns prior to the excavation of the overall basement at the Cheung Kong Centre

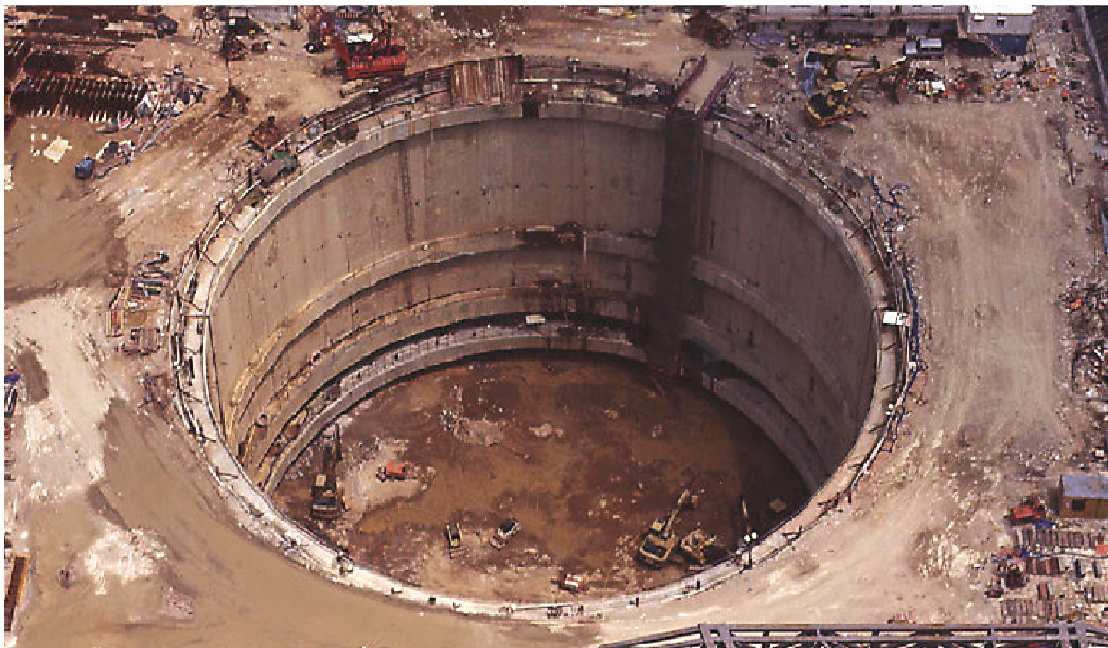
The International Finance Centre 2 (IFC2) made use of a 1.5m thick circular diaphragm wall for the excavation to be progressed for the main core and the mega columns of this 88 storey building. The internal diameter of the shaft was 61.5m and the depth of excavation was 35m. Rock was encountered at the base of the excavation except on one side where there was about 5m of completely decomposed granite at the base. A single 6m thick raft foundation was formed under the core wall and the 8 mega columns. Several barrettes had been pre-installed to support the foundation at the zone where decomposed granite was encountered. Plate 3 shows a general view of the excavation when it was almost complete in 2000. In the same way as for the Cheung Kong Centre the circular diaphragm wall was demolished as the overall basement was subsequently excavated.

Plate 3: View of the excavation for the International Finance Centre 2

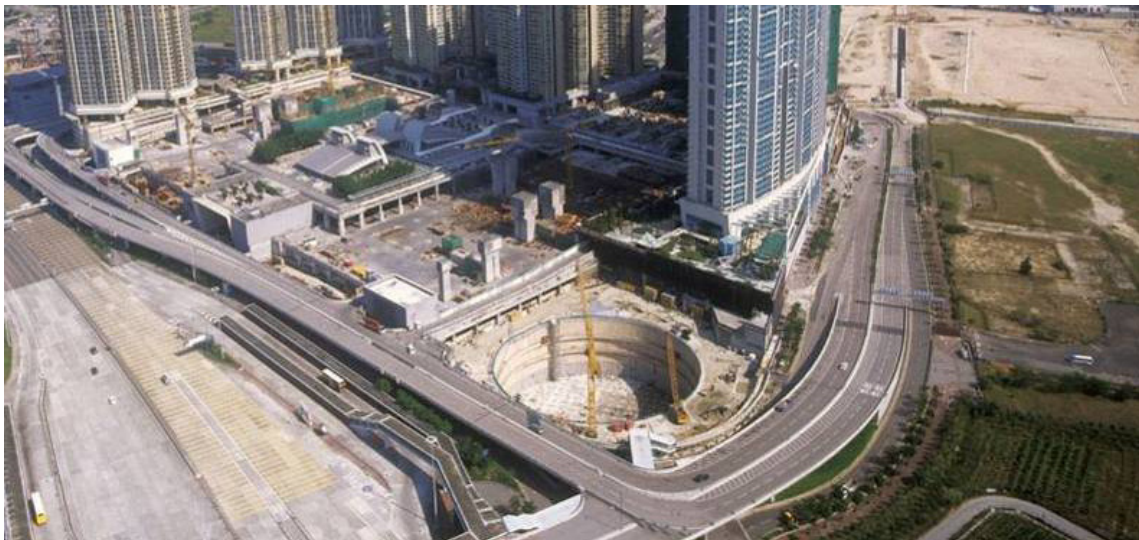
The International Commerce Centre (ICC) again made use of a 1.5m thick circular diaphragm wall for the excavation to be progressed for the main core and the mega columns of this 118 storey building. The internal diameter of the shaft was 76m and the excavation depth was 26m deep. Rockhead was very deep at this site and the building core and mega columns were founded on a 6m thick raft supported by 240 shaft grouted barrettes that extended about 50m below the excavation. The circular diaphragm wall was also used to help support the structure. Plate 4 shows a general view of the excavation that is adjacent to the MTR Kowloon Station and Plate 5 a view looking down on the 240 shaft grouted barrettes. It can be seen that there is a capping beam and two ring beams installed. It should also be noted that this wall was not removed except for the upper few metres.

Plate 4: Overview of the excavation for the International Commerce Centre

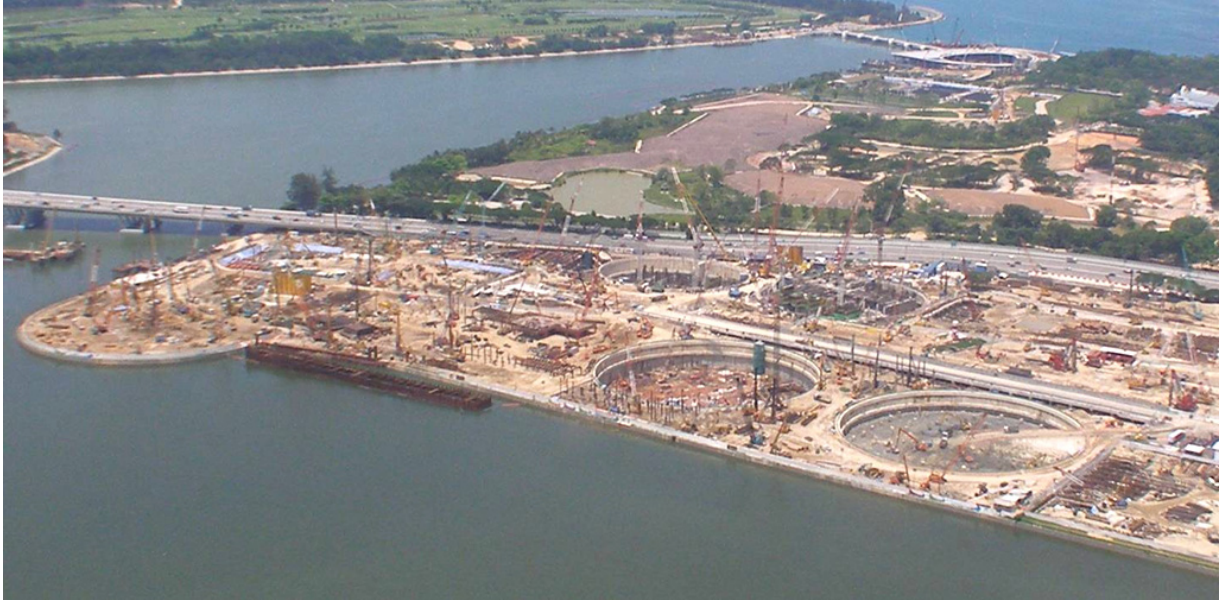
Plate 6: View of the Marina Bay Sands Integrated Resort taken from the south west showing the two 120m diameter circular excavations in the lower foreground, the Hotel Peanut in the upper centre and the 130m diameter outline on the left hand side

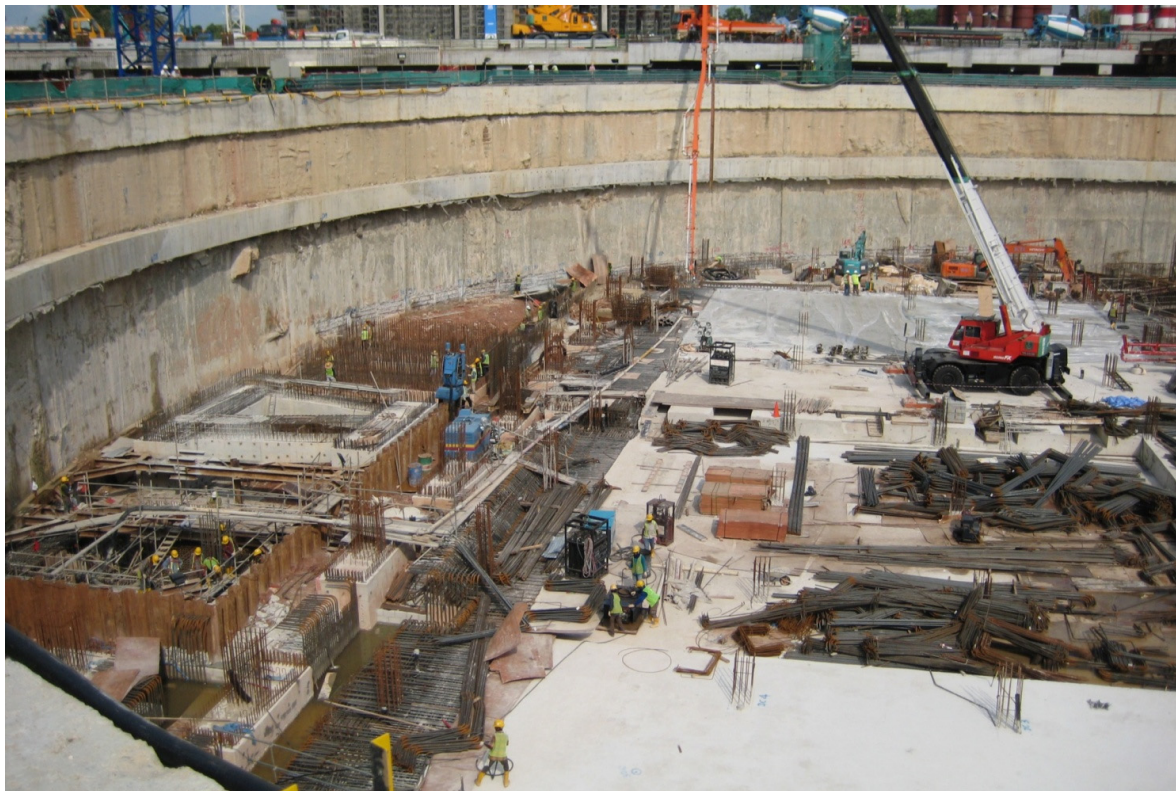
Plate 7: View within the excavation of the northern 120m diameter circular excavation

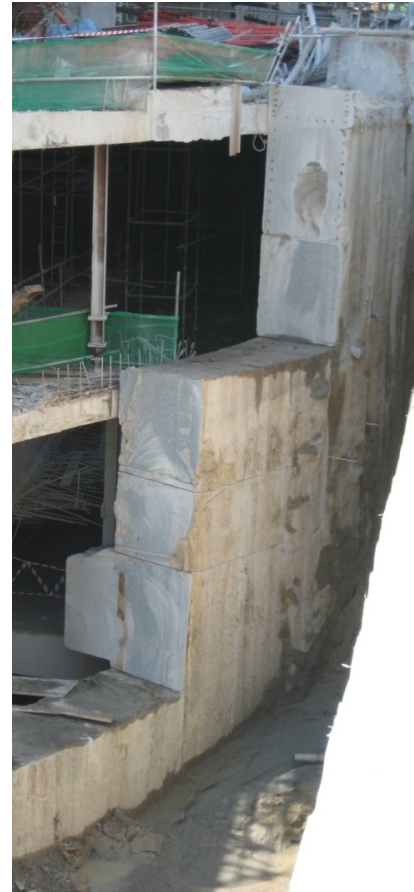
Please note that all of the diaphragm walls forming circular cofferdams that were internal to the perimeter wall were eventually removed down to the base of the excavation. This was achieved by cutting them into blocks using a wire cutter (Plate 8 shows a partially removed wall in the Hotel area). While in the Hotel area this was done as the external excavation progressed beyond them, the walls of the circular cofferdams on the south western part were kept to provide support to the propping that was supporting the perimeter 1.5m thick

Plate 8: View of the Hotel 103m diameter circular diaphragm wall being removed by wire cutting into blocks

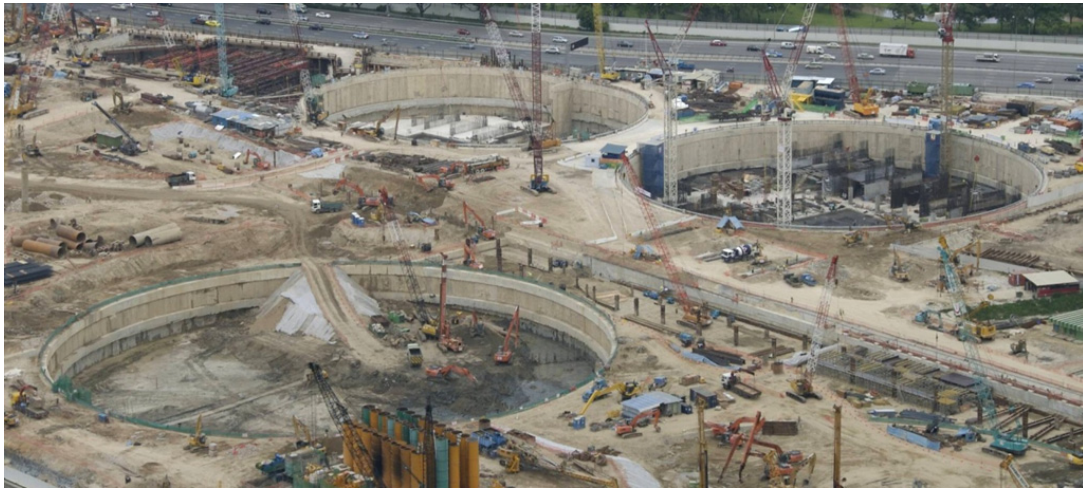
Plate 10: View showing vehicle ramp within the northern 120m diameter circular excavation with Hotel Peanut and 103m circular excavation in the background
