Natural Hillside in Hong Kong
Plan area ~690 km² (total land area 1100 km²)

Post-2010 Landslip Prevention and Mitigation Programme (LPMitP) with respect to natural terrain landslide hazards

Natural Terrain Landslide Risk Management - keep risk to as low as practically achievable level	
Type	Strategy
New Development	Contain risk increase, through study and mitigation action as part of the new development
Existing Development	Undertake action where subject to an immediate and obvious danger or where a dangerous situation could develop 'react-to-known-hazard' principle

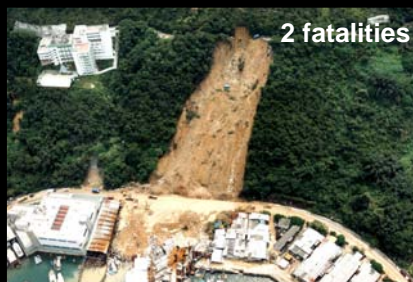
1995 Shum Wan Landslide (26,000 m³)

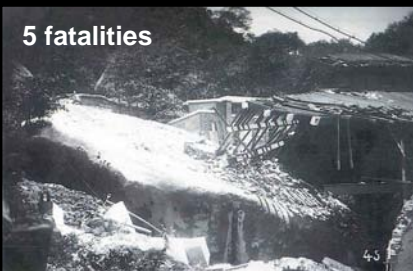
1924 Pokfulam Rock/Boulder Fall

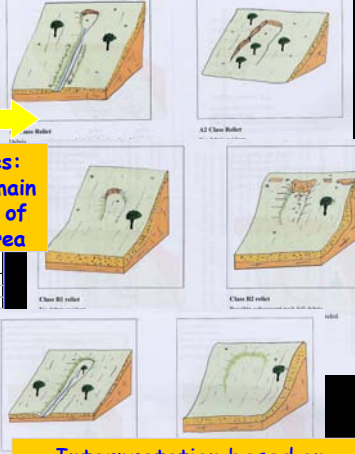
All landslides: width of the main scarp, length of the source area

Interpretation based on terrain characteristics/ morphology of the landslide

Many fields derived using GIS

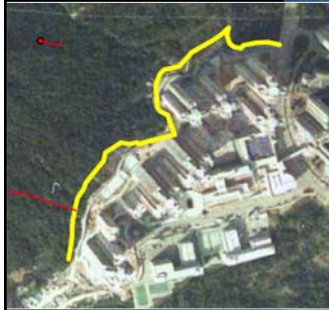
Fanling Area 49A – New Development

Developer carried out natural terrain hazard study and provided debris barriers

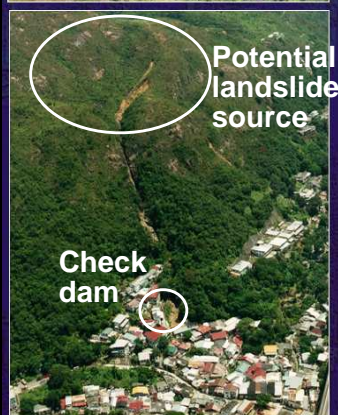
Potential landslide source

Check dam

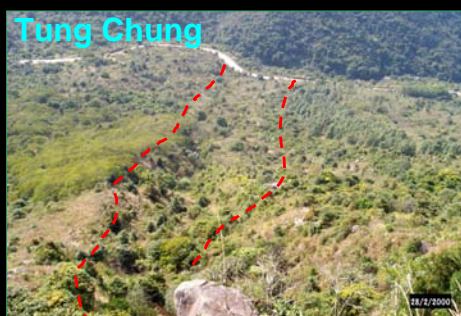
~10,000 years

Probably different climatic conditions compared to the present day

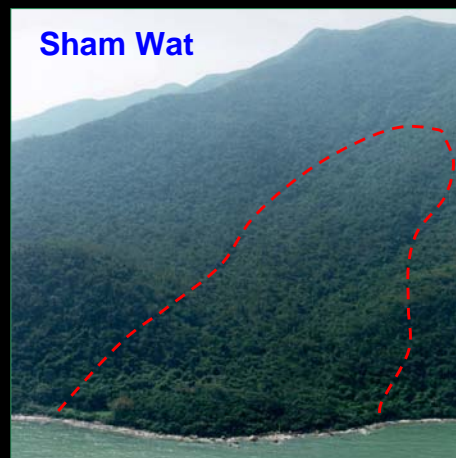
Multiple events
1,000s to 10,000s years

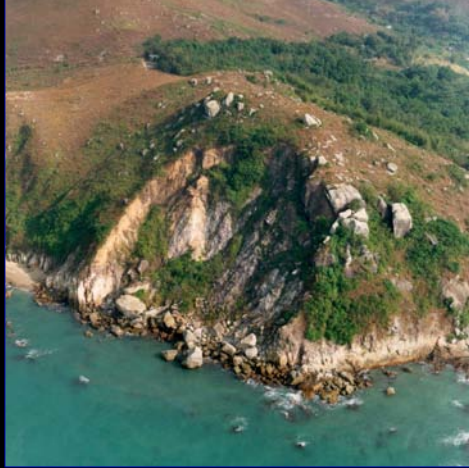
Exhaustion of source

Lamma relict landslide

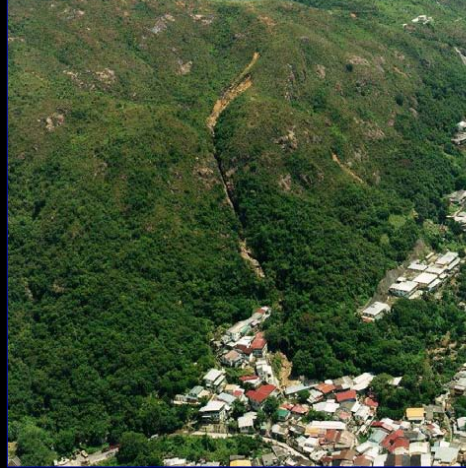
Far from Exhaustion

1999 Sham Tseng
San Tsuen debris flow

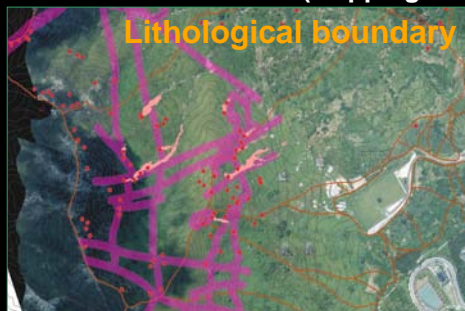
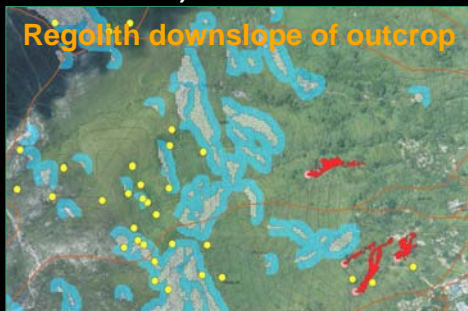
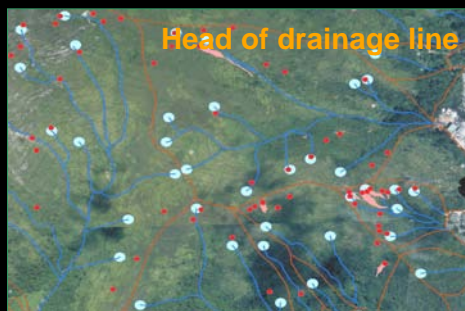
Tsing Shan Study - Susceptibility Analysis

(Mapping – 1:2000 to 1:5000)

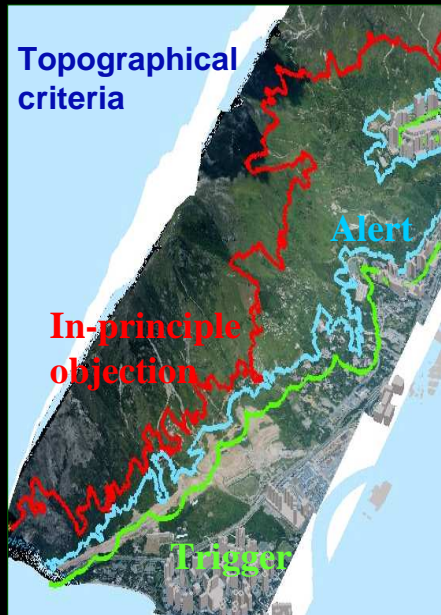
Landslide Hazard Map – Area-based Study (Tsing Shan)

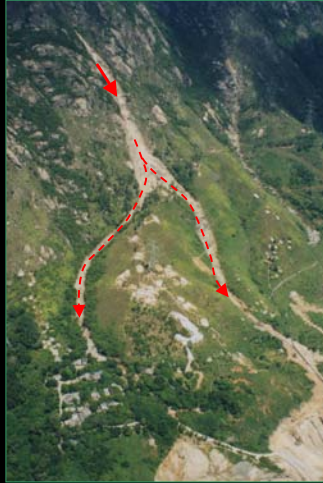
Dynamic Modeling in GIS

- Debris 3-D runout path
- Runout distance & velocity

Debris Mobility Modeling

- 2000 Tsing Shan Debris Flow
