Recent Development in Natural Terrain Landslide Risk Management and Mitigation

Shatin Heights, Shatin

Tung Wan, Lantau Island

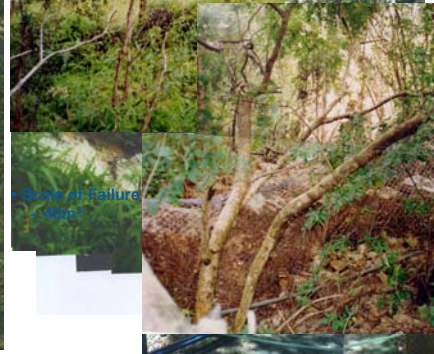
• Scale of Failure
~ 40m

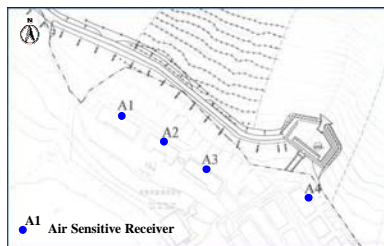
Air Pollution Impacts and Mitigation Measures

- Source of Impacts
 - Dust nuisance and gaseous emissions arising from construction plant and vehicles, construction activities such as drilling of soil nails and bulk excavation.
- Mitigation Measures
 - Regular watering
 - Tarpaulin covering to dusty vehicle loads
 - Establishment of vehicle washing facilities

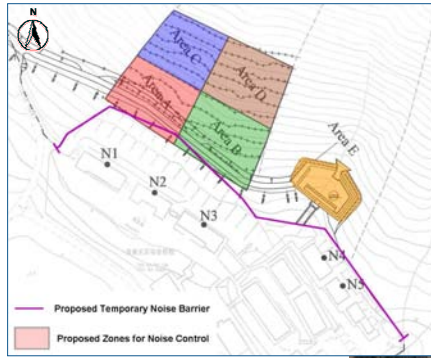
Noise Pollution Impact

- Usage of Powered Mechanical Plants, such as air compressor, drilling rig, backhoe and roller during construction
- Noise Sensitive Receivers (N1 to N5) situated in close proximity (around 10m)

- Adoption of Quiet Powered Mechanical Equipment [reduced 11dB(A)]
- Restriction in the 24H percentage on-time
- Operation of Temporary Noise Barrier compressors for soil nails installation in Areas A, B, C, D and E simultaneously is not allowed
- Using of Temporary Noise Barrier [reduced 10dB(A)]

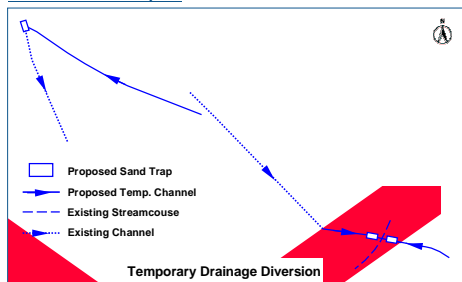
Water Pollution Impact

- Sewage arising from the on-site construction
- Runoff and drainage during construction phase
- Contains suspended solids and contaminants

- Properly treat the runoff by using sedimentation tanks or silt traps
- Discharge the construction effluent and foul to the public sewer or streamcourse should be strictly prohibited

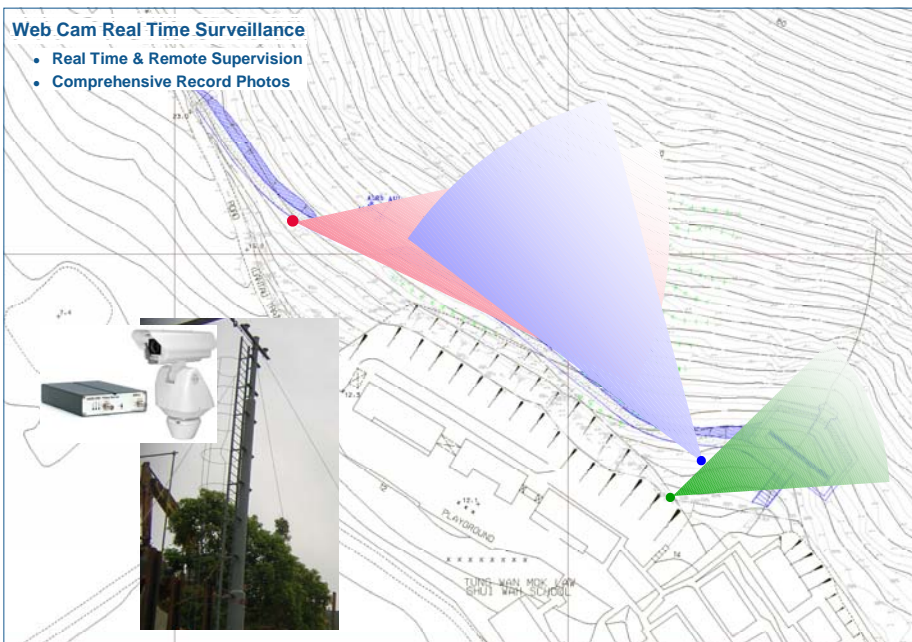
Web Cam Real Time Surveillance

- Real Time & Remote Supervision
- Comprehensive Record Photos

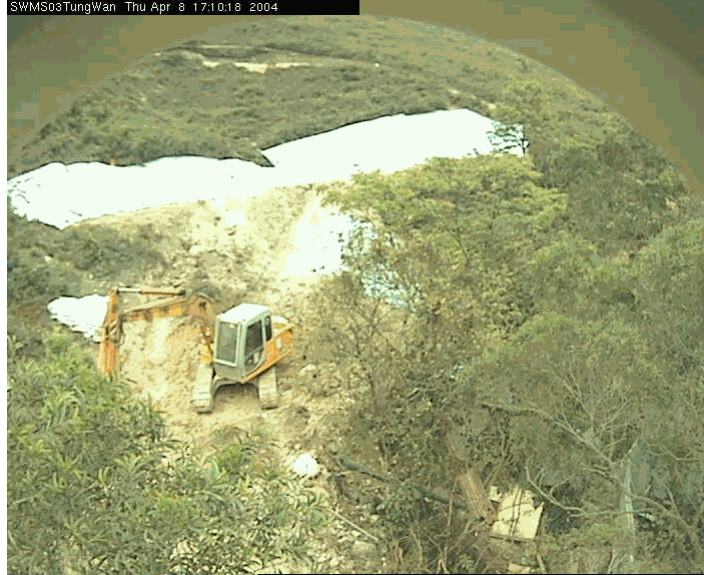
SWMS03TungWan Thu Apr 8 17:10:18 2004

Real Time Records
