# Landslide Risk Reduction through Works

## *35 Years of Landslip Preventive Measures Programme and Beyond*

**Proceedings of the 31st Annual Seminar  
Geotechnical Division, The Hong Kong Institution of Engineers**

**Landslide Risk Reduction through Works:  
thirty-five years of landslip preventive measures  
programme and beyond**

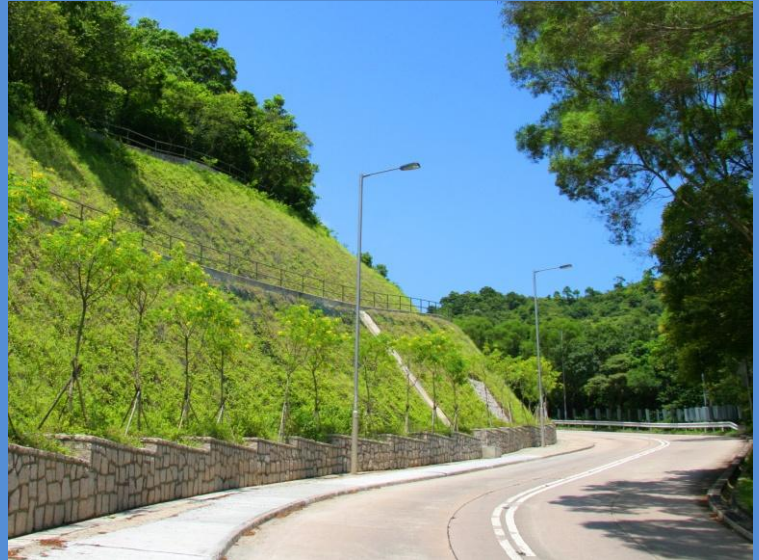
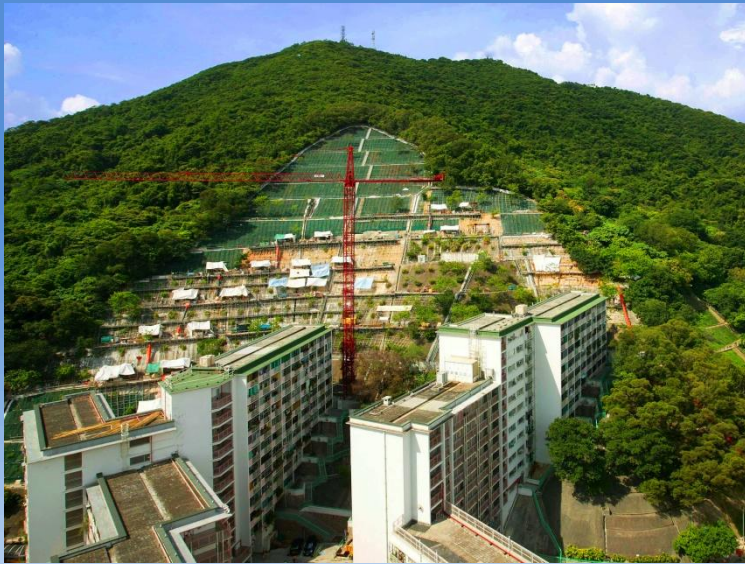
**Captions of Figures on the Front Cover**

Top-left: Annual LPM expenditure  
Top-right: A road-side slope in Lantau upgraded under LPM Programme in 2003  
Bottom-left: A 100 m high cut slope overlooking Sai Wan Estate in Kennedy Town  
being upgraded under LPM Programme in 2007  
Bottom-right: Landslide risk in Hong Kong

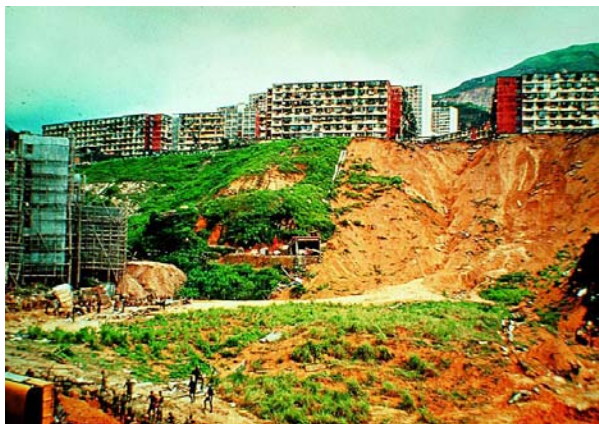
Figure 1: Landslide at Sau Mau Ping in 1972

On 18 June 1972 two disastrous landslides occurred rendering it the darkest day in the history of landslide disasters in Hong Kong. One of these landslides involved the collapse of a 40-m high road embankment in the Sau Mau Ping Resettlement Estate. The resulting flowslide engulfed a temporary housing area, killing 71 people and injuring 60 others (Figure 1). The other occurred in a steep hillside in a residential area at Po Shan Road. The debris demolished a 13-storey building, killing 67 people and injuring 20 others (Figure 2).

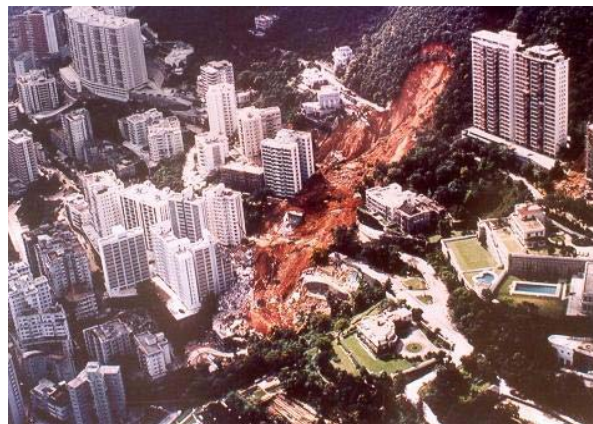
Figure 2: Landslide at Po Shan Road in 1972

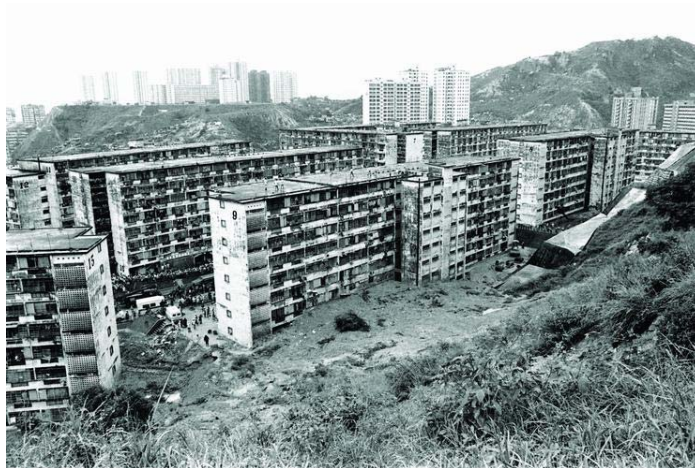
Figure 3: Landslide at Sau Mau Ping in 1976

In 1976, another disastrous landslide occurred at a 35-m high embankment in Sau Mau Ping, killing 18 people and injuring 24 others (Figure 3). The Government quickly appointed an Independent Review Panel comprising local and international geotechnical experts to investigate this landslide and make recommendations to deal with the slope safety problems in Hong Kong. The investigation revealed that the fill of the failed embankment was formed by end-tipping and was not adequately compacted. In view of the possibility that such conditions might be widespread, the Government extended the Phase II Landslide Study to include identification and inspection of sizable fill slopes in the territory. 2351 fill slopes were subsequently identified, 670 of which were considered as posing high or moderate risk to the public.

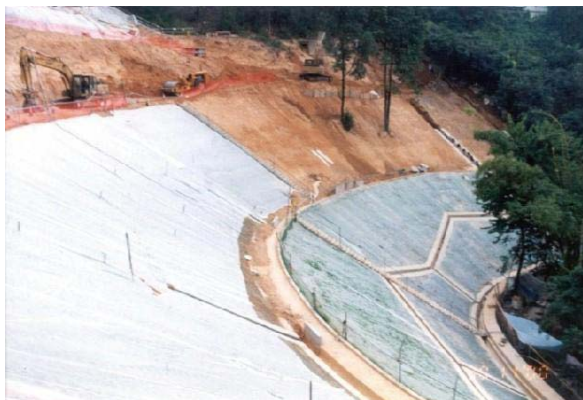
Figure 4: Recompaction of Loose Fill Slope

Immediately after the Sau Mau Ping landslide in 1976, emphasis was given to find and retrofit more than 100 loose fill slopes amongst the extensive platform areas on which public housing had been constructed in the 1960s and 1970s. Substandard loose fill slopes were retrofitted by recompactifying the top 3 m of the fill bodies (Figure 4). Other novel techniques such as dynamic compaction (Figure 5) and the installation of sand compaction piles had also been experimented to identify means to expedite the treatment of loose fill slopes (Lam 1980). Substandard cut slopes were generally stabilized by cutting back the slope face to a flatter gradient. The design and supervision of engineering works were entrusted to the consultants until 1983, when it was taken over by GCO and handled by in-house staff.

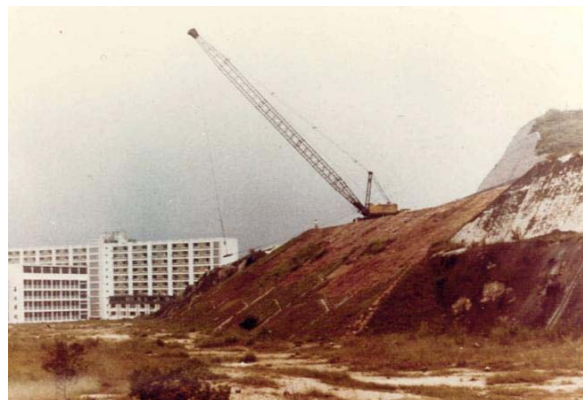
Figure 5: Dynamic Compaction of Loose Fill Slope (Lam 1980)

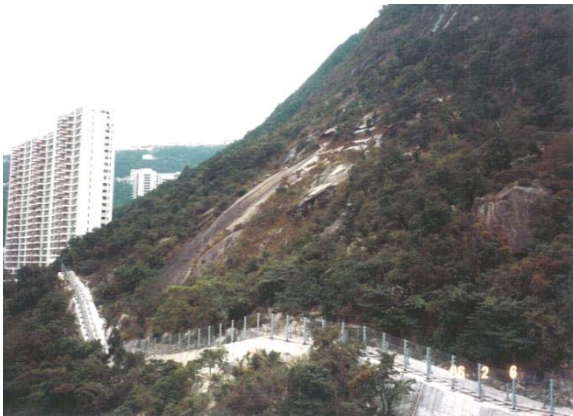
Figure 7: Boulder Fence at Mid-levels

A boulder fall incident occurred in 1981 resulting in one casualty. It prompted the GCO to initiate the Mid-levels Boulder Field Preventive Works Pilot Scheme on the natural hillsides above Conduit Road which had a history of boulder falls. The study aimed at developing techniques for mapping the boulder field and identifying suitable strategy for boulder treatment. This study led to the insitu stabilization of boulders and the construction of a flexible boulder fence (Figure 7) in mitigating the boulder fall hazard in the area (Chan et al. 1986; Au & Chan 1991).

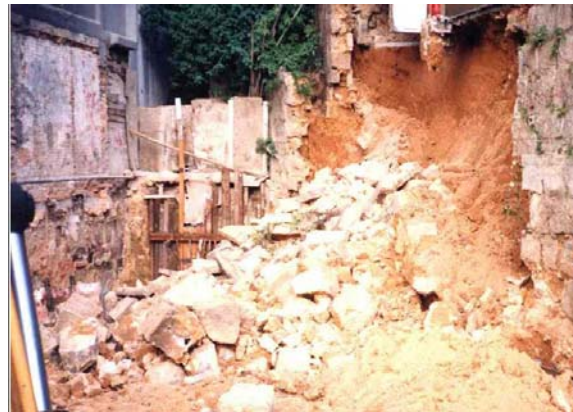
Figure 8: Failure of a Typical Masonry Wall

- A masonry retaining wall study was conducted in 1981 (Chan 1982) to examine the construction practice and structure of masonry walls in Hong Kong. It reviewed past failure incidents (Figure 8) to gain better understanding of their structural behavior and put forward investigative techniques and remedial actions for masonry walls.
- A study designated as “CHASE” (Cut Slopes in Hong Kong – Assessment of Stability by Empiricism) was carried out to aim at establishing simple means to expedite stability assessments for existing slopes and design of cut slopes in weathered soils. Data on stable and failed slopes (Figure 9) were analyzed to develop some simple semi-empirical guidelines for initial stability assessment for cut slopes (Brand & Hudson 1982).

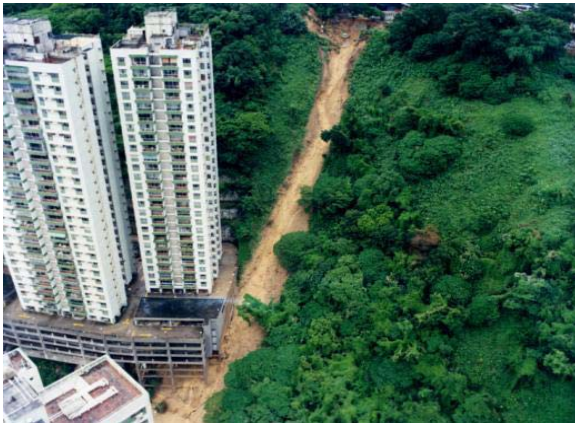
Figure 13: Landslide at Baguio Villas in 1992

A major landslide involving the failure of an unregistered masonry wall of 9 m high retaining a fill platform in a former dairy farm above Baguio Villas occurred in May 1992 (Figure 13). A large volume of loose fill materials was released and flowed down along a gully towards Baguio Villas causing two fatalities, five injuries and evacuation of 1,500 residents. This landslide brought to light that the 1977/78 Catalogue of Slopes was incomplete. It did not include all slopes formed before 1977 nor the many new slopes that have been formed since. Noting the need for a territory-wide slope re-cataloguing exercise, the GEO quickly launched the Systematic Inspection of Features in the Territory (SIFT) project to search for unregistered

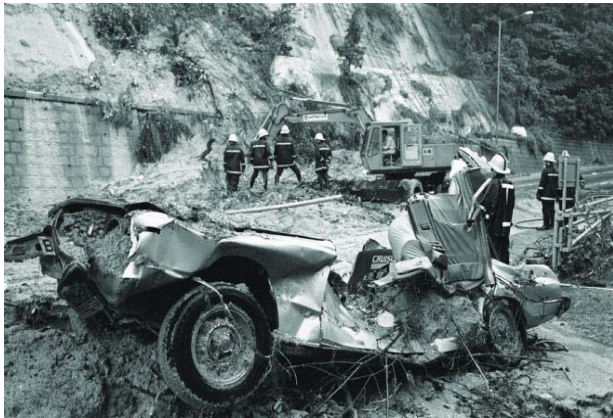
Figure 14: Kennedy Road Landslide in 1992

On the morning of the Baguio Villas landslide, a fatal landslide also occurred at Kennedy Road killing one person and seriously disrupted the road traffic (Figure 14). In 1993, a landslide occurred on a cut slope adjacent to the Cheung Shan Estate bus terminus at Kwai Chung. The landslide debris inundated a bus shelter killing one person and injuring five others (Figure 15). The failures at these slopes affecting busy roads and pedestrian pavement were generally accorded a relatively low priority under the LPM Programme at the time. In consideration of the number of landslides at these slopes and the consequence of failures had been aggravated over the years due to increasing traffic density, more LPM resources were allocated to retrofit roadside slopes.

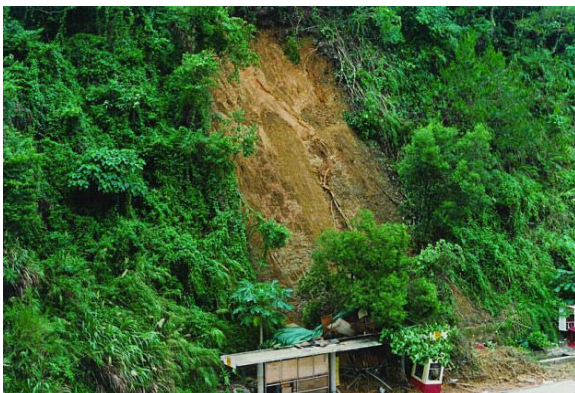
Figure 15: Landslide at Cheung Shan Estate Bus Terminus in 1993

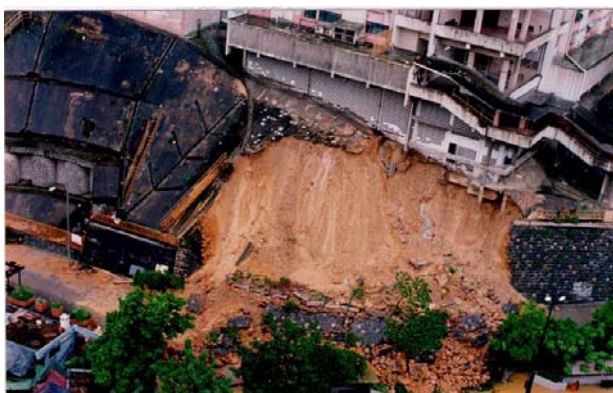
Figure 16: Kwun Lung Lau Landslide in 1994

In 1994, the collapse of an old masonry wall below Block D of Kwun Lung Lau, which was previously assessed by a preliminary study under the LPM Programme as well as by geotechnical consultants engaged by the private owners, aroused considerable public outcry. The failure (Figure 16) resulted in five fatalities, three serious injuries and temporary evacuation of some 3,900 residents for fear of collapse of the building when its foundations were partly exposed after the failure. Public censure ensued when it was made known that only a small percentage of the slopes in the 1977/78 Slope Catalogue had been treated under the LPM Programme up to that time. Politicians called for a substantial injection of resources into slope safety.

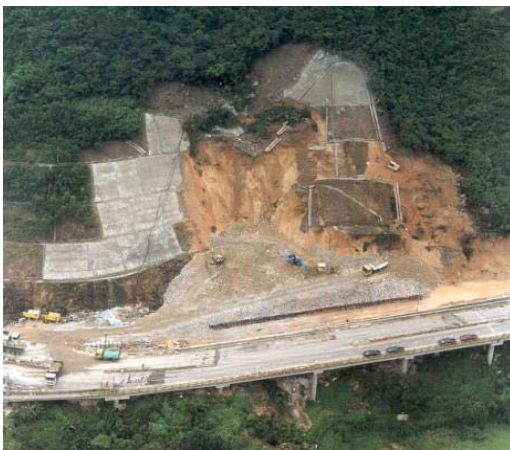
Figure 17: Landslide at Ching Cheung Road in 1997

In the mid to late 1990s, several slopes that had gone through a proper design process failed. These engineered slopes were designed by means of the limit equilibrium method to a slope gradient with an acceptable factor of safety and were constructed to the design profile. The slope failures highlighted the vulnerability of slope design (by cutting back) to uncertainties. Notable examples of slope failures were a landslide at a cut slope along a carriageway, Ching Cheung Road, in 1997 (Halcrow 1998) and a distressed cut slope affecting several public housing blocks at Shek Kip Mei in 1999 (Fugro Maunsell Scott Wilson Joint Venture 2000). The Ching Cheung Road and Shek Kip Mei landslides (Figures 17 and 18) highlighted the limitations of ground investigation and slope assessment practice and the vulnerability of cut slopes to adverse

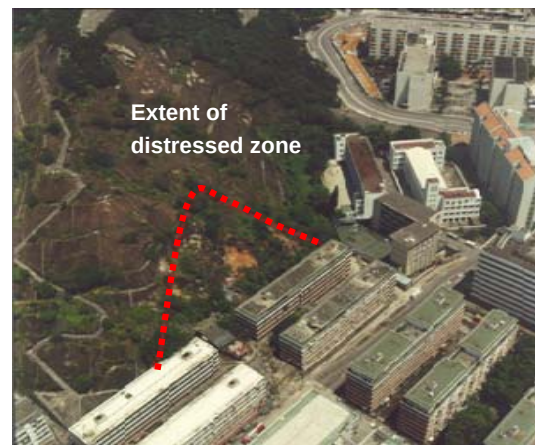
Figure 18: Landslide at Shek Kip Mei in 1999

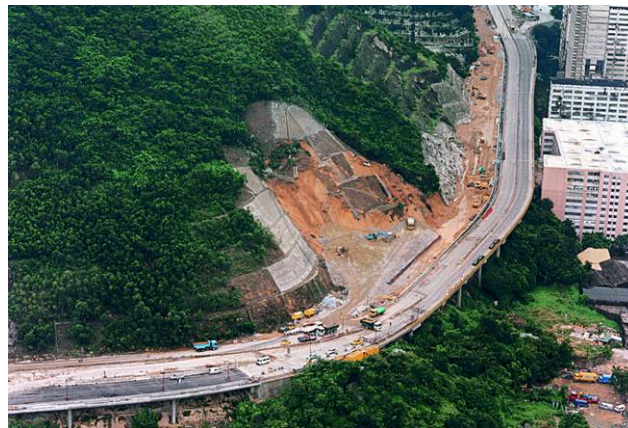
Figure 12: The 1997 Ching Cheung Road landslide

Systematic landslide investigation (LI) is an integral part of the LPM Programme. All landslides reported to the GEO are examined and screened in order to identify cases that warrant follow-up study. Worthy cases, such as the Ching Cheung Road landslide in 1997 (Figure 12), are studied in detail to document the failure and relevant background information, establish the probable causes, and identify the necessary follow-up actions. Amongst the numerous benefits, systematic LI is found to be very useful in identification of slope types in need of early attention under the LPM Programme and to improve the knowledge on the causes and mechanisms of landslides in Hong Kong so as to formulate new ideas for reducing landslide risk and enhancing the reliability of slope upgrading works (Chan & Ho 2001).

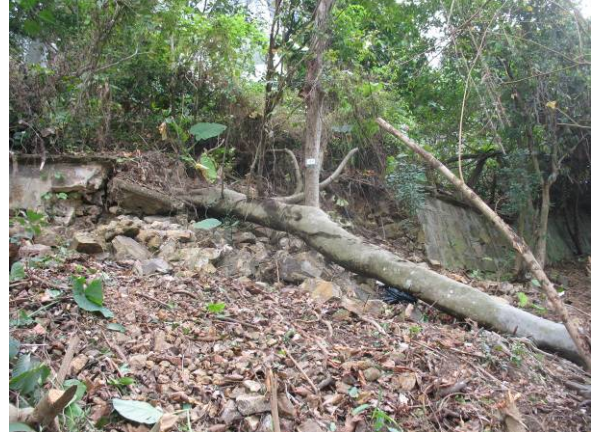
Figure 3: Distressed masonry wall

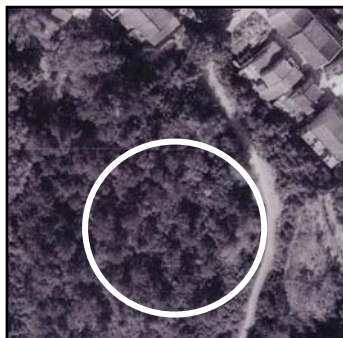
Plate 1: 1976 Aerial Photograph  
(no building or slope)

A detailed review of the available aerial photographs was carried out to determine the formation history and cutting evidence for Slope A. In the 1976 aerial photograph (Plate 1), neither the building nor Slope A had been formed, while in the 1977 aerial photograph (Plate 2), both the building and Slope A were visible. Such records indicated that Slope A was formed between 1976 and 1977, most likely in association with the development of Lot 1. Based on this cutting evidence and the Cutting Away Clause in the Lease, the owner of Lot 1 was held responsible for Slope A. Hence, a DH Order was served on the lot owner.

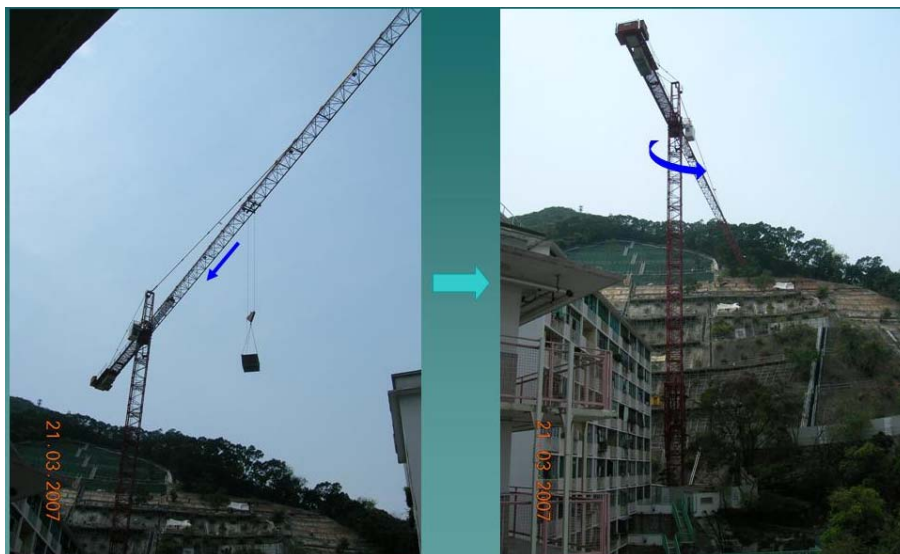
Figure 2: The operation procedure of tower crane presented in the Residents' Forum

With the assistance from a member of Central and Western District Council, the residents were invited to join a forum held at a children playground of the estate. The forum provided a useful platform for the project team to brief the residents, the management office of the estate about the problem of slope safety in Hong Kong and the need for LPM works. All relevant issues including site constraints, construction difficulties, site safety etc. were discussed during the forum and attendants raised a number of questions about the construction works. Some residents expressed concerns on the safety of the tower crane operation. With the aid of sketches and photos, the contractor presented the operation procedure of the tower crane and pointed out that the extent

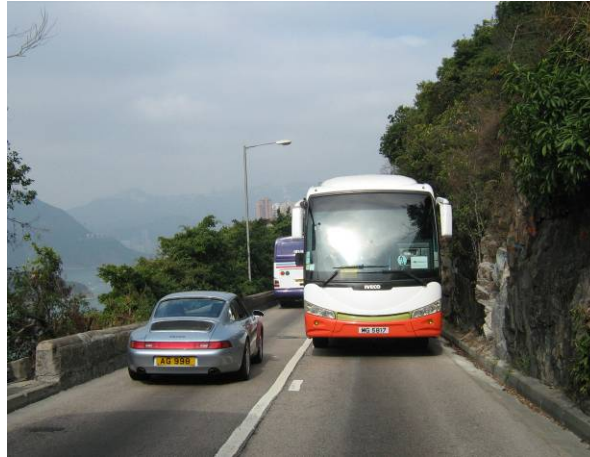
Plate 1: Typical narrow and busy road with cut slope, Repulse Bay Road, Hong Kong.

The roads under discussion are generally a single carriageway with 2 lanes and footpath on one side only or occasionally absent. See plate 1.

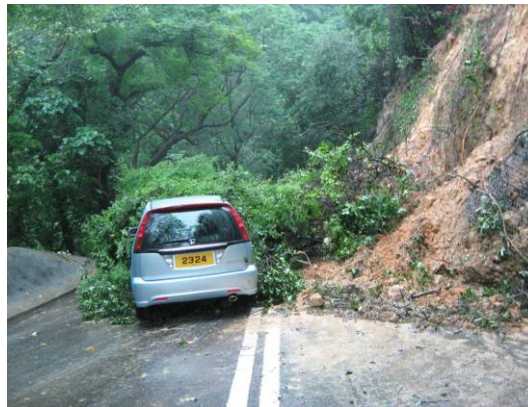
Plate 2: Landslide in weathered volcanic rock, Repulse Bay Road, Hong Kong, June 2008

Most slope works along busy roads have involved stabilisation of cut slopes above the carriageway. Typically the cuts were made in decomposed rock, weathering grade IV and V, with less frequent cuts wholly or partly in rock, weathering grades I, II and III. During intense rainfall, local and transient perched water develops resulting in local failures often involving relict jointing. See plate 2.

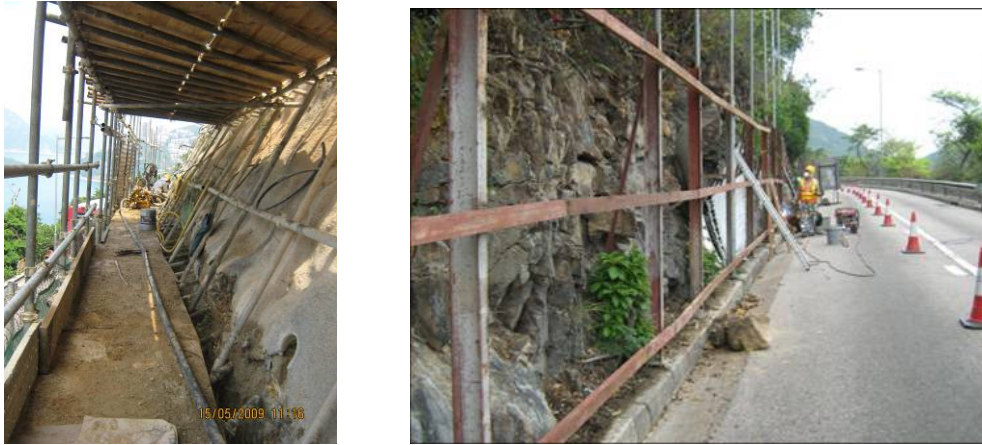
Plate 4: Temporary working platform, 1.1m width, Repulse Bay Road, Hong Kong

Where lane closure has to be restricted to a minimum, temporary steelwork structures founded at or near the slope toe are erected to support narrow platforms. Specially modified pneumatic and electric powered drilling rigs are used to install soil nails or rock dowels. Tight control of safety and environmental issues is necessary under those circumstances. See plate 4.

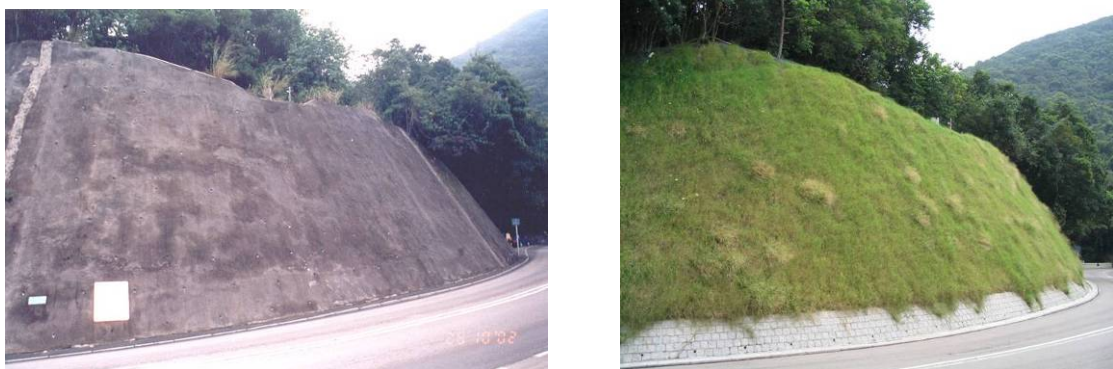
Plate 5: Slope with existing shotcrete surface before and after slope works, Stubbs Road, Hong Kong

Roadside slopes are highly visible to the general public and hence a pleasing appearance is a high priority. Government policy requires hard surfaces to be minimized. On the other hand the finished works must be robust and require minimum maintenance. Local failures of soil nailed vegetated slopes have been reported, (Ng et al 2008). Many existing slopes are covered with a hard surfacing such as chunam or shotcrete. Removal of existing hard surface and replacement with erosion control mat and wire mesh fixed to nail heads has enabled many slopes to be vegetated particularly for slopes upto about 55 degrees, (GEO 2000 and 2007). See Plate 5.

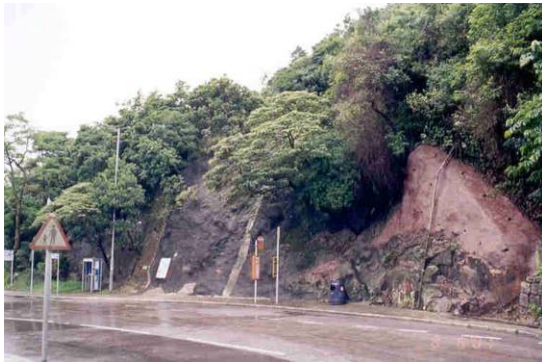
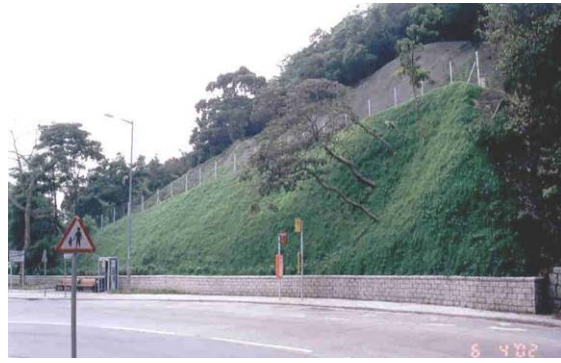
Plate 6: Slope with existing shotcrete surface before and after slope works including application of continuous fibre reinforced soil, Peak Road, Hong Kong

Ground investigation of slopes cannot fully characterize the slope forming material over the whole slope. Often removal of existing hard surface reveals unexpected conditions, for example underlying hard material that cannot support vegetation. Under such circumstances a new hard surface may have to be applied, such as sprayed concrete with colour painting and planter holes reserved for climbing plants. Where lane closures are restricted there is little time to review and revise the landscape scheme. Under such circumstances a conservative assumption about ground conditions is warranted to ensure timely completion of works. An alternative approach is to adopt a slope greening system such as continuous fibre reinforced soil which can be applied over hard surfaces and provides a growing medium for grass and shrubs, (Ho & Mak 2005). See Plate 6.

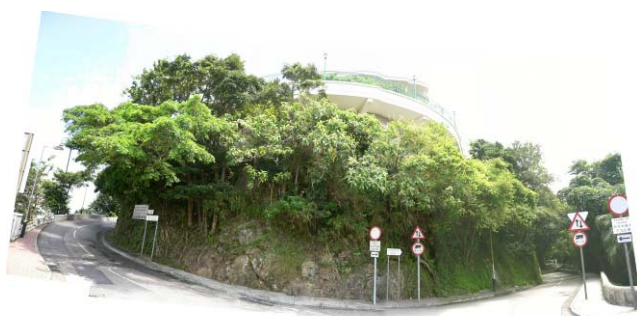
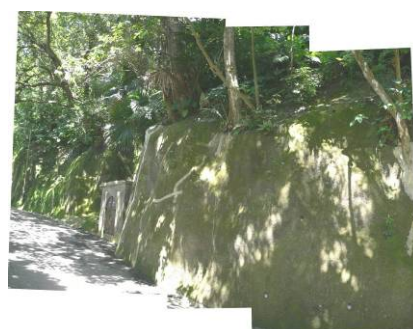
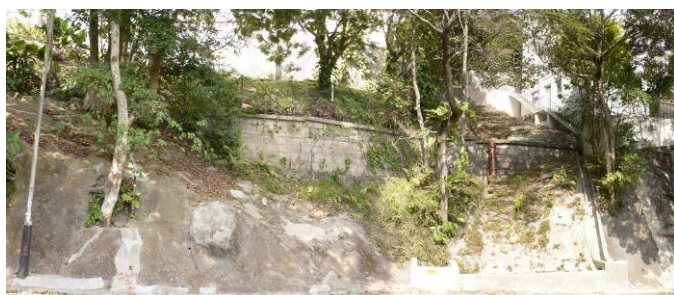
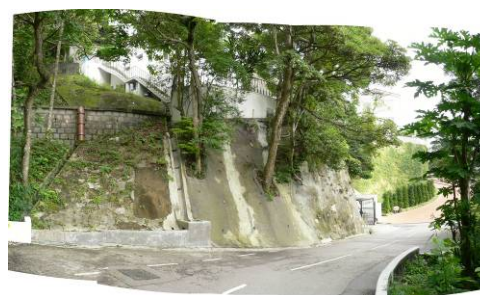
Plate 1: General view of features before LPM works

Before LPM works, Feature nos. 11SW-D/C524, 11SW-D/C529, 11SW-D/CR530 and 11SW-D/CR1225 varied from 9m to 25m in height and slope angles ranged from 30° to 75°, and the Government portions of these features were covered by chunam with presence of some mature trees. General view of the features before LPM works is shown in Plate 1. The section of Coombe Road in front of the features was about 4m to 5m wide. Typically, this kind of roadside cut slopes can be upgraded by conventional soil nailing method. However, as mentioned, the commonly adopted soil nailing method was not feasible at this site because intrusion of soil nails into private lots was not possible.

(a) Feature no. 11SW-D/C524

(b) Feature no. 11SW-D/C529

(c) Feature no. 11SW-D/CR1225

(d) Feature no. 11SW-D/CR530

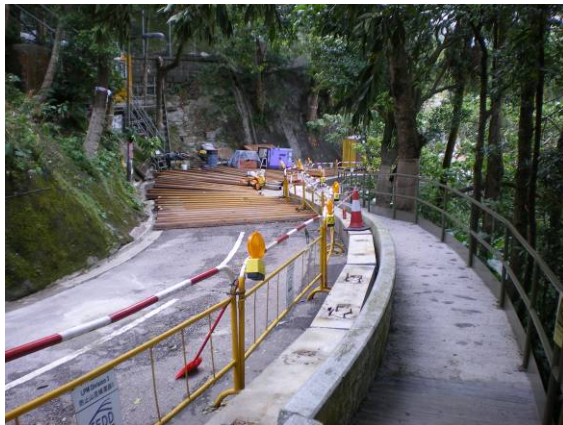
Plate 2: Temporary pedestrian walkway

implementation of the road closure, a temporary walkway of about 120m long would be provided outside the site boundary, i.e. at the sloping ground alongside Coombe Road, to maintain pedestrian flow. The project team then immediately submitted urgent applications to District Lands Office (DLO) and HyD for simplified temporary land allocation (STLA) and excavation permit (XP) for construction of the elevated temporary walkway. DLO and HyD were helpful to process the applications and the applications were approved within short period of time. While the STLA and XP applications for the walkway were still in process, the contractor prepared the design of the temporary walkway in advance and also implemented a partial lane closure at Coombe Road to carry out pre-drilling for socketed H-piles. This could minimise the effects of the temporary walkway on the overall site progress. The completed temporary walkway is shown in Plate 2.

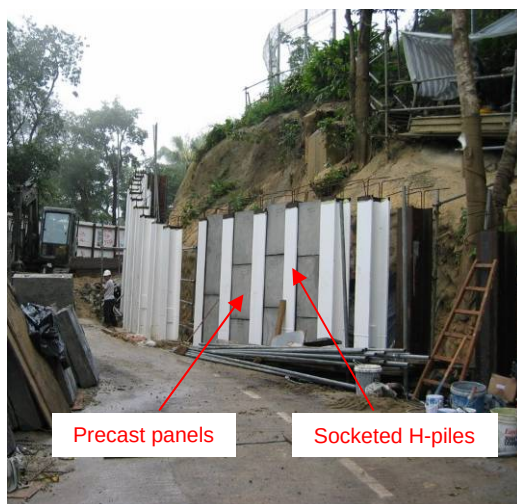
Plate 4: Construction of retaining wall

The alignment of proposed piled retaining wall followed the toe line of the features which was smoothly curved in plan (see Plate 4). For this reason, the position and orientation of the socketed H-piles had to be very precise, otherwise, a small deviation would result in difficulty in subsequent installation process of precast reinforced concrete panels between the piles and adversely affect the intended smooth visual appearance of the retaining wall. To achieve this, the survey teams from the contractor and the site supervision team worked closely together and carried out frequent joint surveys and the contractor also worked diligently and adjusted the orientation of the piles throughout grouting operation. Apart from the orientation of the piles, construction of the capping beams along the crest of retaining wall was also a challenging task. The contractor deployed skilful and experienced labour and supervision staff for setting out and erection of formwork to ensure the smoothly curved alignment of the structure.

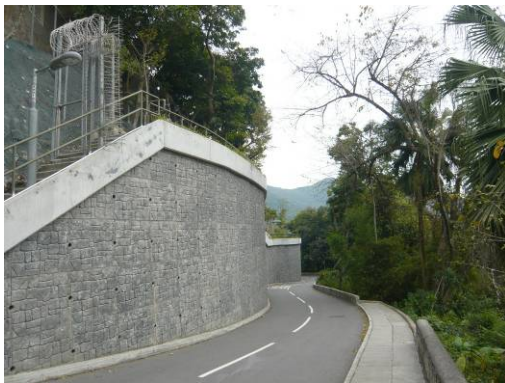
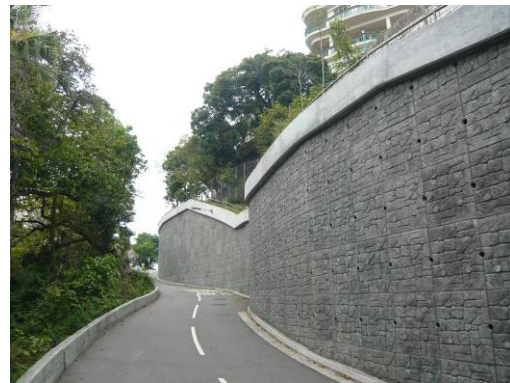
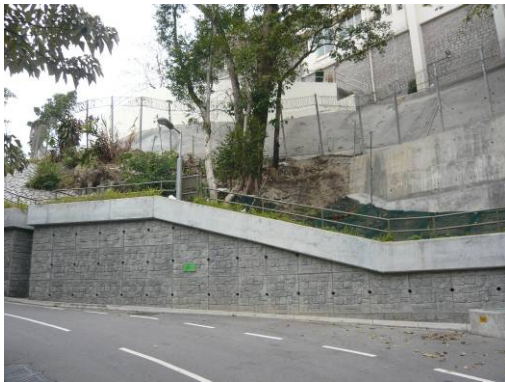
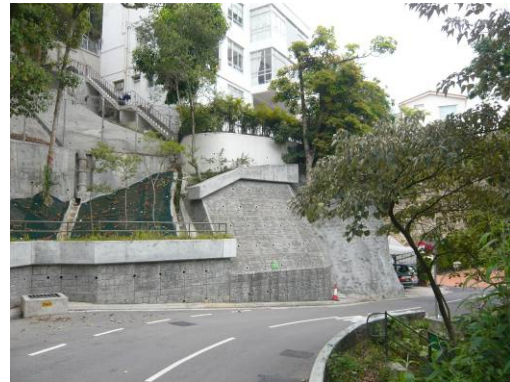
Plate 6: Completed retaining wall founded on socketed H-piles at Coombe Road

During construction stage, there were a number of requests from nearby residents for re-opening of Coombe Road as early as possible. In order to minimise the disturbance to the residents, the designers, site supervision team and contractor worked closely and cooperatively as an united team to overcome the difficulties and challenges encountered, and managed to complete all critical works in June 2009. This allowed early re-opening of Coombe Road (see Plate 5) and the disturbance to the nearby residents was minimised. The local residents were very appreciative of the efforts made by the project team. Eventually, the LPM works on the four features at Coombe Road were successfully completed in October 2009. The completed retaining wall at Coombe Road is shown in Plate 6, and its aesthetic design blended very well with the surroundings.

(a) Feature no. 11SW-D/C524

(b) Feature no. 11SW-D/C529

(c) Feature no. 11SW-D/CR1225

(d) Feature no. 11SW-D/CR530

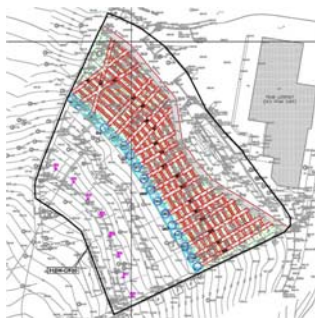
Figure 2: Layout of improvement works

The excavation for the additional pile wall by machine was considered to be too risky as the Grade II Historic Building at the slope crest had a history of distress. Hand-dug caisson was considered the only option. A row of total seventeen hand-dug caissons of 1.8m diameter and 3m spacing was proposed to improve the stability of the slope. The proposed hand-dug caissons would be located at an elevation of about +380.0mPD at mid-height of the study feature. To gain sufficient lateral resistance, the caissons were socketted at least 7m in Grade III or better rock. As a result, the length of the caissons ranged from 18m to 23m (see Figures 2, 3 and 4).

A row of 10m long prescriptive raking drains and surface drainage channels were also proposed in the detailed design. Soft landscaping works would then be provided to the slope surface to enhance the aesthetic appearance of the slope.

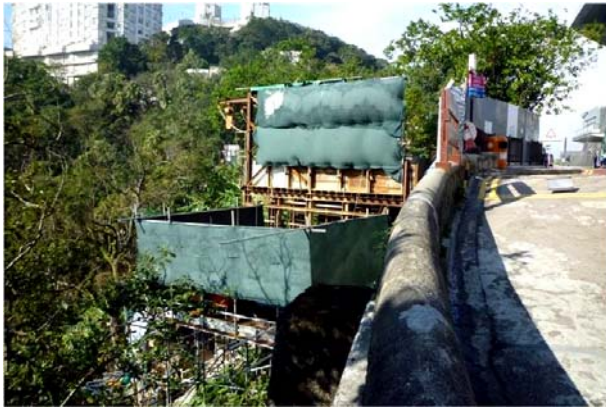
In order to facilitate the construction works, a temporary stockpiling platform and other temporary working platforms were erected prior to the commencement of the hand-dug caisson construction. The temporary steel stockpiling platform was erected at the northeast to the site as shown in Plate 1. This temporary stockpiling platform was used for providing space for temporary storage of construction material and excavated materials.

Plate 1: Temporary stockpiling platform

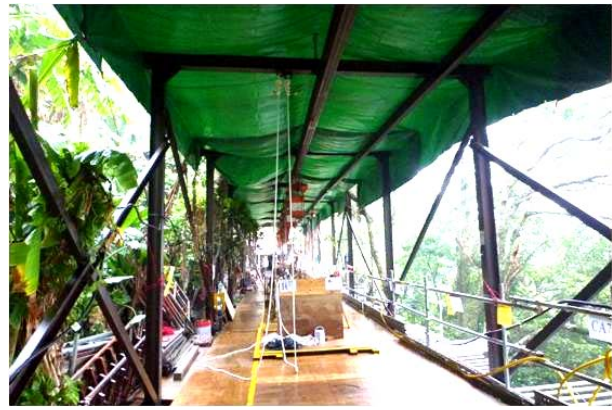
Apart from the temporary stockpiling platform, a temporary working platform was also erected over all seventeen hand-dug caissons to provide working space for access, material transportation and hand-dug caisson construction works. A structural steel gantry was erected along the seventeen caissons with electric chain blocks for transportation of workers and materials within the caissons and along the working scaffolding platform (see Plate 2). All electric chain blocks together with the gantry were tested and thoroughly examined by a competent examiner.

Plate 2: Temporary working platform and steel gantry

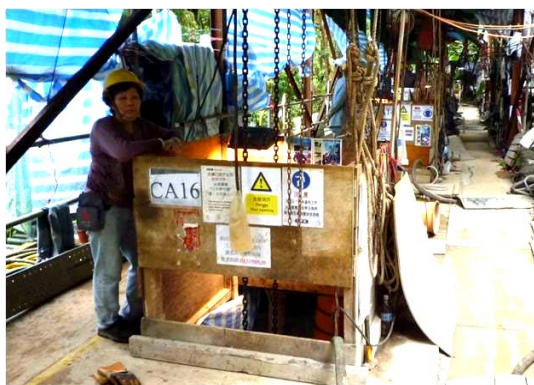
The edges of the caisson openings had been fenced with guard-rails with height of 1150mm in accordance with F&IU regulations to prevent any persons from falling. Toe boards with minimum height of 200mm were also provided to the caisson openings to prevent objects from falling (Plate 3). The caissons were securely covered and locked with warning sign when no works were carried out within the caissons to prohibit unauthorized entry.

Plate 3: Provision of barriers and toeboards at caisson opening

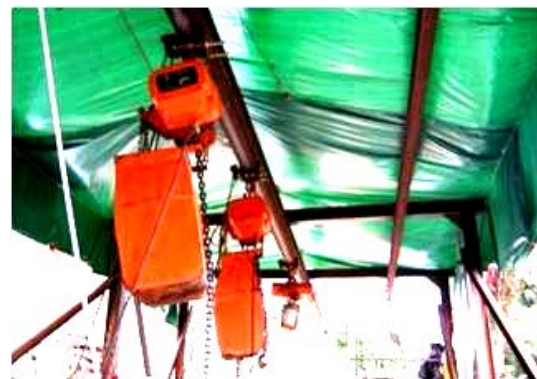
Plate 4: Chain blocks

Above each caisson opening, a pair of chain blocks was established at the steel gantry (see Plate 4), one chain block would carry a material bucket (Plate 5) and the other chain block would carry the man-cage (Plate 6). The lifting of the material bucket and man-cage inside the caisson requires specific sequence in order to

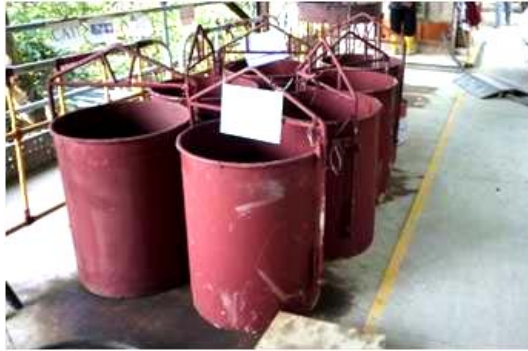
Plate 5: Material buckets

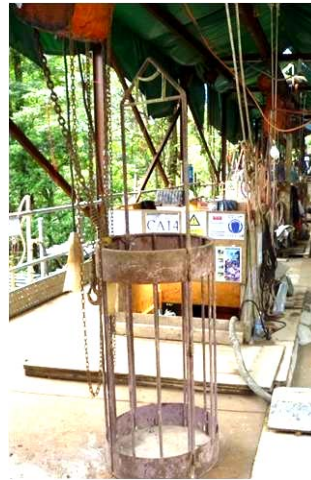
Plate 6: Man-cage

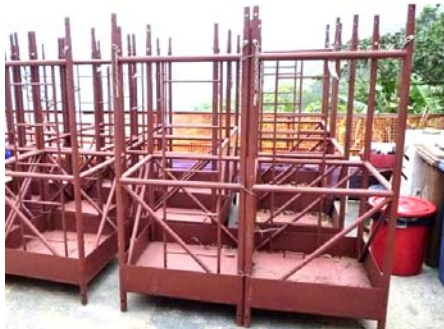
Plate 7: Climbing mast

In order to minimize the hazard to the workers during reinforcement fixing of the caisson, a set of pre-fabricated steel scaffold (named as “climbing mast”) was developed and transported into the caisson by electric chain blocks to allow workers to move up/down inside the caisson (Plates 7 and 8). A site specific lifting derrick had also been set up adjacent to the caisson for lifting vertical reinforcement bars into it (Plate 9).

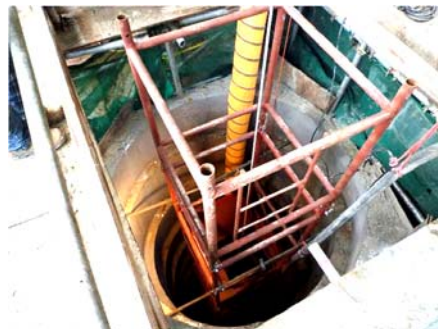
Plate 8: Climbing mast inside caisson

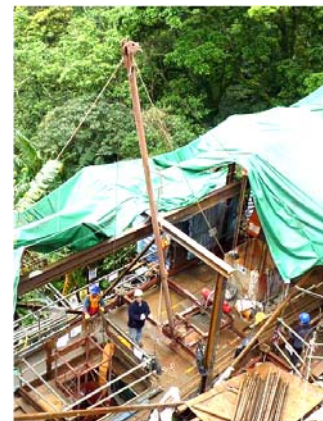
Plate 9: Lifting derrick

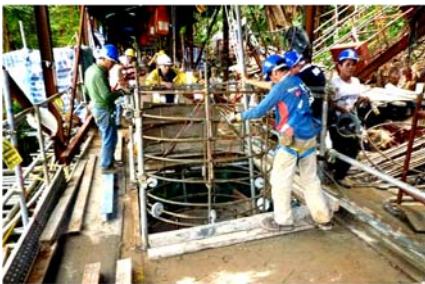
Plate 10: Reinforcement cage

Firstly, a reinforcement cage of the 25mm-dia. circular links would be fixed with some temporary 25mm-dia. vertical steel bars above the caisson opening. The reinforcement cage were hung and gradually lowered by the electric chain block at the gantry (Plate 10). Once a 12m long reinforcement cage completed, the cage would be lowered to the bottom of the caisson by the chain blocks. The 40mm-dia. steel bar would be then lifted and lowered to the bottom of caisson one by one using the lifting derrick (Plate 11). The workers would then enter the caisson through the climbing mast and fix the 40mm-dia. steel bars to the 25mm-dia. circular links (Plate 12). The temporary 25mm-dia. vertical bars of the cage would then be lifted up by the derrick.

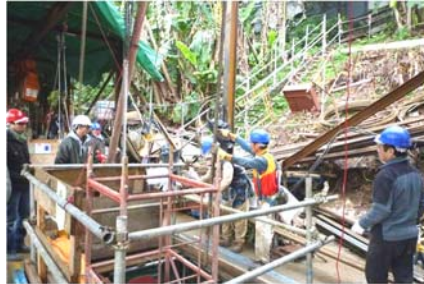
Plate 11: Lowering of 40mm dia. steel bar by lifting derrick

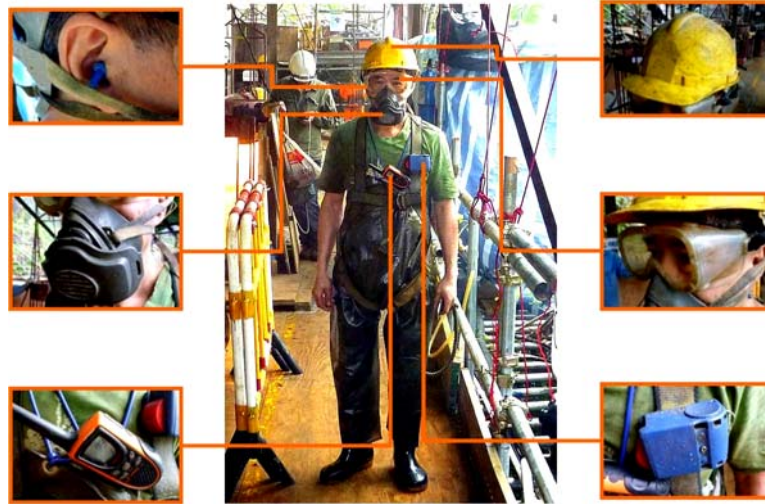
The worker entering the caisson should put on adequate personal protective equipment, including suitable safety helmet, eye protector, ear protectors, and respirator (see Plate 13). A portable alarm device would also be equipped with the caisson worker. The alarm device had been designed with significant loud buzz to draw the co-worker's attention on ground when the carrier is motionless for a specific time inside the caisson.

Plate 13: Personal protective measures for caisson workers

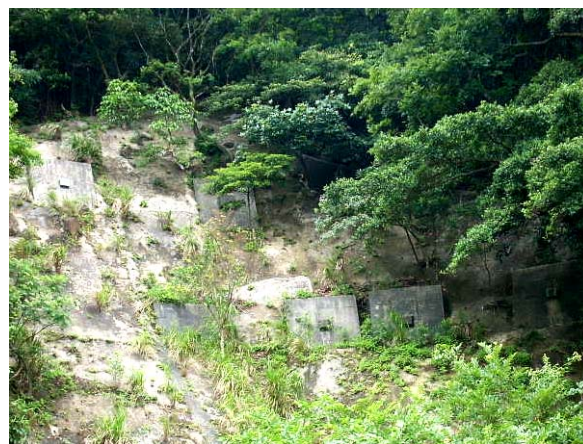
Plate 1: Existing anchors

The subject slope was covered with chunam surface, which was in poor condition that cracks were noticeable and vegetations were found growing through the surface at various locations of the slope. A total of 22 anchors with anchor heads of 2.3m x 2.3m were scattered on the slope surface (see Plate 1). Some boulders were located on the natural hillside to the south of the feature, which suggests the presence of colluvial deposits.

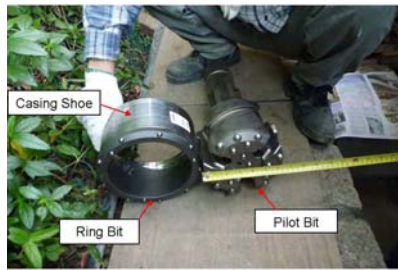
Plate 2: Ring bit and pilot bit for concentric drilling

Concentric drilling method comprises a casing system with a pilot bit with large internal flushing holes and external flushing grooves, a ring bit with internal bayonet coupling and a casing shoe (see Plates 2 and 3). The pilot bit is attached to the ring bit with a bayonet coupling (See Plate 4). Both rotate clockwise and together cut the hole, which is sufficiently large to allow the casing shoe to pull down the casing. The ring bit rotates freely on the casing shoe, which is welded to the first casing pipe. During drilling the casing pipe does not rotate.

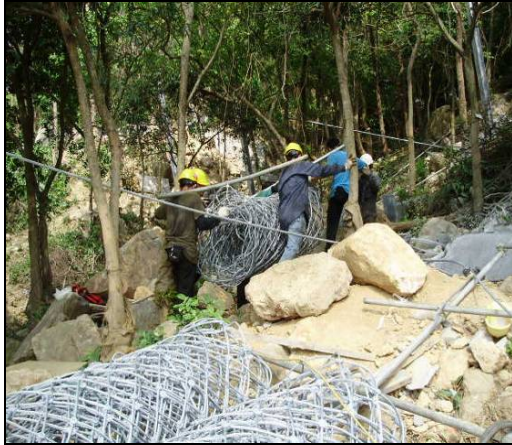
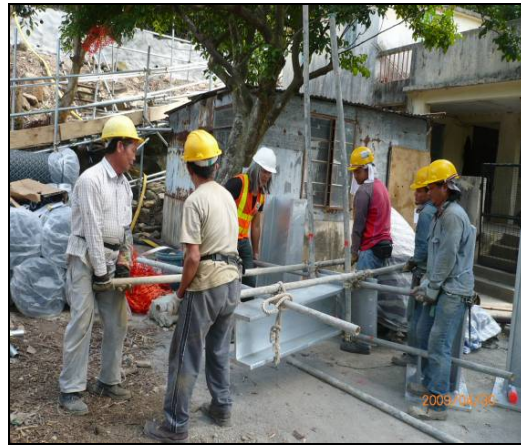
Plates 2 & 3: Manual handling of the wire mesh and steel baffle of flexible barrier at NC7a

For the remote site at NC7a, it was necessary to transport the plants and flexible barrier components manually to the works area located behind the terraced village houses through small village footpaths, private lots and heavily-vegetated slopes. The walking distance between the unloading point and the works was over 300 m. In addition to the 5m high by 80 m long steel wire mesh for the flexible barriers, the contractor was required to deliver 15 steel posts and 9 steel baffles, each about 1 tonne in weight, to the works area (Plates 2 & 3).

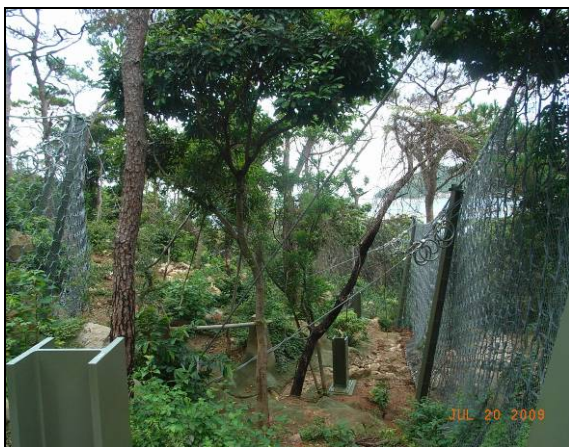
Plate 4: Flexible barriers and baffles erected at NC6

Unlike NC7a, the contractor was able to mobilize a small backhoe to the works area of NC6 to assist in the fabrication and erection of flexible barriers. In addition, the alignment of the flexible barriers was set on a relatively even ground profile (Plate 4). Hence, the construction of flexible barriers at NC6 was completed faster and with less difficulty as compared to that at NC7a.

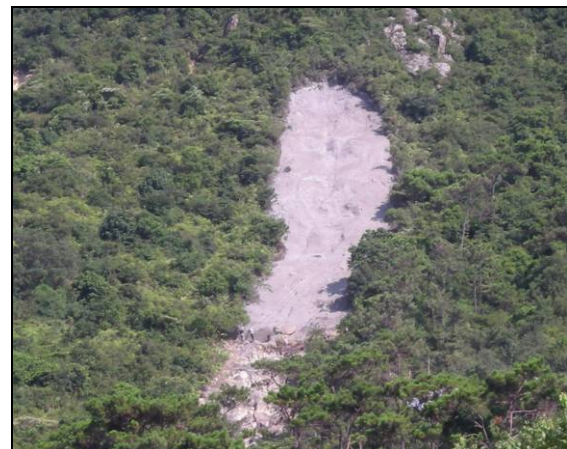
Plate 5: The shotcrete at failure scar of NC6

The emergency repair works mainly consisted of removal of all loose materials and application of spray-concrete to the failure scars (Plate 5). The major challenges in spray-concreting works were the substantial height of work (+180 mPD), steep failure scar surfaces and the need to complete the works within a very tight time schedule.

The sprayed concrete surfaces at NC6 and NC7 turned the natural hillsides above Nam Chung Tsuen into an eyesore (Plate 5) which attracted numerous criticisms from the residents, tourists and a local environmental green group. Greening of the sprayed concrete scar surfaces was, therefore, included as a major item in the risk mitigation works in order to improve the slope appearance. Under the close supervision of a landscape architect, many trials had been carried out on site to determine the most suitable landscaping works on the sprayed concrete surfaces. Finally, the scheme entailing the use of khaki pattern painting with large planter plots on the sprayed concrete surfaces was adopted (Plates 8 & 9).

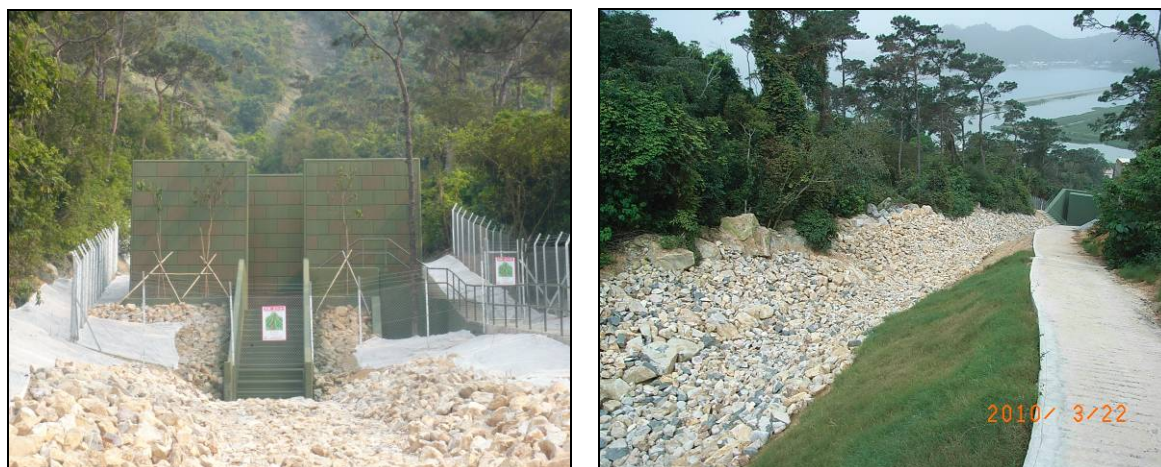
Plates 6 & 7: Completed RC check dam and re-profiled stream course at NC7

To ensure the quality of the concreting works, casting of the check dam was carried out in several portions. At the time, the demand of concrete in South and West Lantau Island was very high due to various construction works, including other urgent slope repair and upgrading works, being carried out concurrently. The project team and the contractor maintained close liaison with senior management of the concrete supplier who subsequently agreed to reserve all concrete trucks on the dates of concreting of the check dam with adequate advance notification. With proper planning and sorting out of all necessary details beforehand, concreting of the check dam was completed in a smooth manner (Plate 6).

Another challenge was re-profiling of stream course at NC7, including removal of the temporary haul road. The original natural stream course was completely buried with the landslide debris and boulders. Many of the boulders were as large as 3m<sup>3</sup> spreading over the landslide trail. To reinstate the stream course to its original condition, the large boulders were broken up and the splitted rock blocks were used to form the embankment of the stream course (Plate 7).

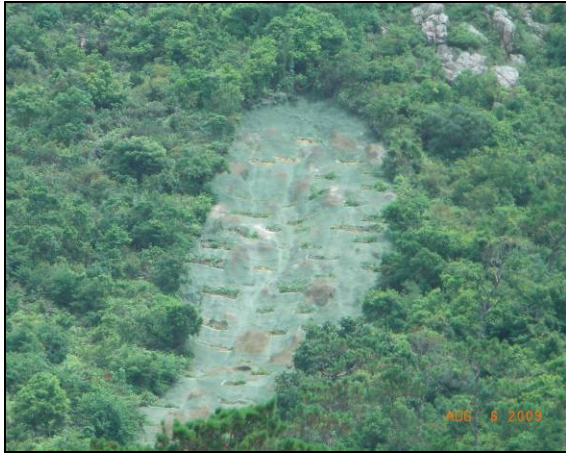
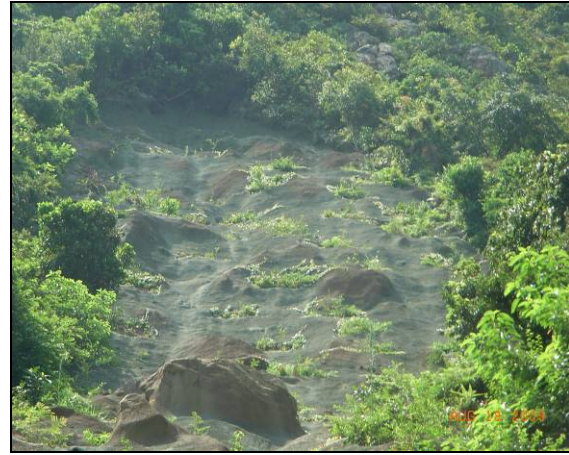
Plates 8 &amp; 9: Painting and planter plots at NC 6

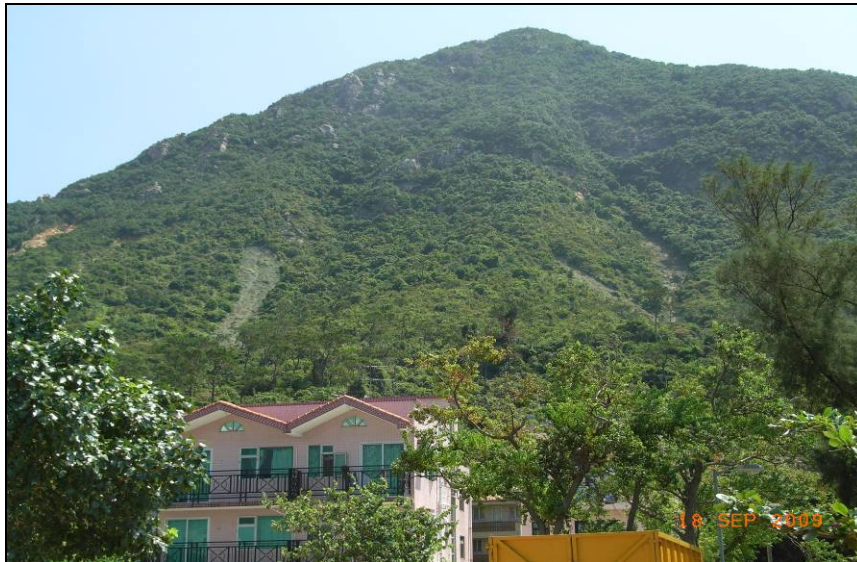
Plate 10: Completed landscaping works on slip scars of NC6 and NC7

Because of the steep terrain, greening of the sprayed concrete surface was a difficult and time consuming process. For safety reasons, it was necessary to erect double layers of bamboo scaffolding on the scar surfaces in order to carry out the painting works, and remove part of sprayed concrete surface for plot planting. After the completion of these landscaping works, the two large eye-catching sprayed concrete surfaces disappeared and the scars had successfully blended in with the surrounding natural hillsides (Plate 10).

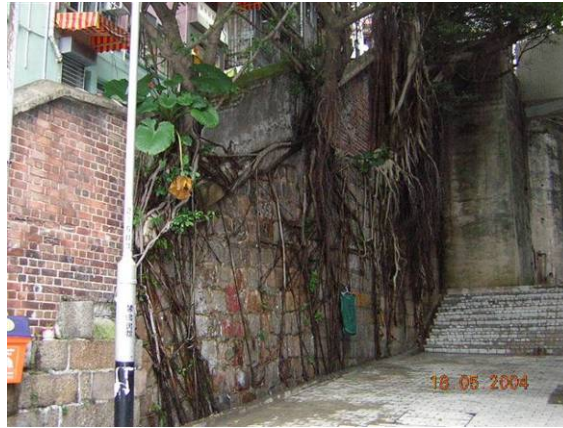
Plate 1: Proposed mass wall was in conflict with the roots of existing wall trees at Feature No. 11NW-A/R88 in Ladder Street (photo taken before works on 18 May 2004).

A mass retaining wall was proposed to be constructed at Feature No. 11SW-A/R88 in Ladder Street, Sheung Wan, Hong Kong in June 2004. However, the proposed mass wall was in conflict with the tree roots of three numbers of existing wall trees as shown on Plate 1. It was proposed to remove part of the roots to facilitate the construction works. The Landscape Unit was then consulted and they requested the root pruning works to be carried out by specialist contractor and supervised by a chartered landscape architect. Furthermore, one year maintenance period was required after completion of the pruning works.
