# Landslide Risk Reduction through Works

## *35 Years of Landslip Preventive Measures Programme and Beyond*

**Proceedings of the 31st Annual Seminar  
Geotechnical Division, The Hong Kong Institution of Engineers**

**Landslide Risk Reduction through Works:  
thirty-five years of landslip preventive measures  
programme and beyond**

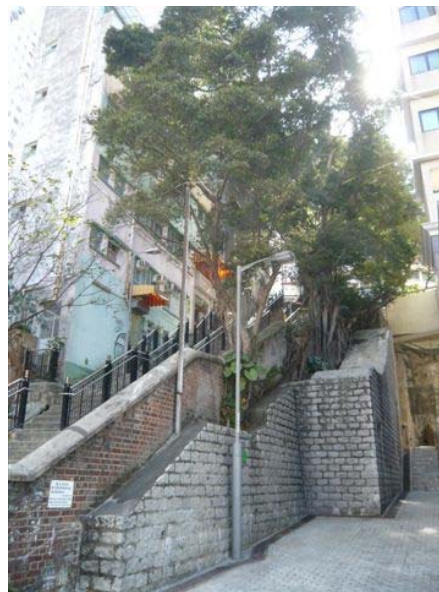
Plate 2: Wall trees were still in good condition after five years of the works (photo taken on 7 February 2011).

The root pruning works was carried out in three stages with one month after each stage. Some branches of the trees were also pruned in order to reduce water lost by evaporation. The trees were closely monitored and progress reports were submitted to Landscape Unit on monthly basis. The mass wall construction works was completed in May 2005. No abnormal sign (e.g. fallen leaves) was observed on the wall trees during the construction and in the maintenance period. The wall trees were still in good condition after five years of the construction works as shown on Plate 2.

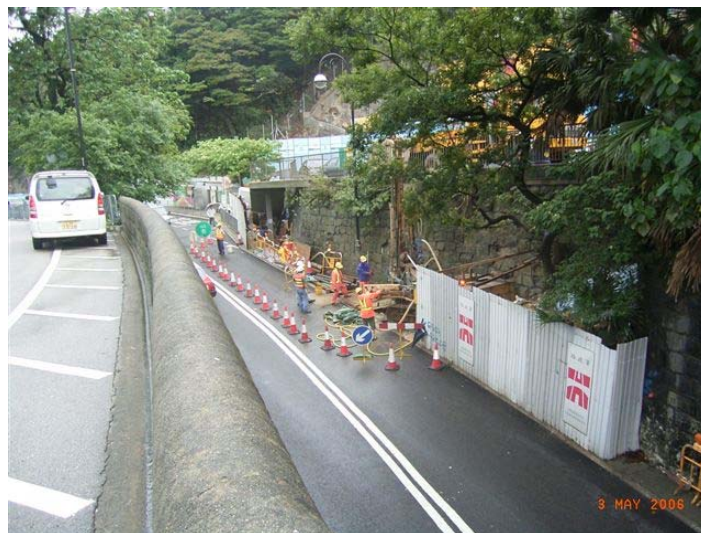
Plate 3: TTA for piling works at 11SW-C/R62 in Peak Road.

An L-shaped reinforced concrete retaining wall supported by mini-piles was proposed to be constructed at Feature No. 11SW-C/R62 in Peak Road, Hong Kong Island. It was necessary to close one of the two traffic lanes for the piling works. The works site was close to a signalized junction and a bus stop. The traffic flow was heavy during peak hours. TD required the TTA to be implemented only in non peak hours from 10:00am to 4:00pm in order to reduce the traffic impact. The contractor was required to set up and remove the traffic signs and cones each day. Trial run was conducted before implementation of the TTA scheme. The TTA set up was illustrated on Plate 3.

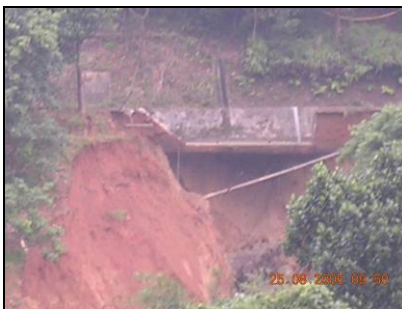
Plate 1: General view of slope failure

On 21 August 2005, a major landslide occurred at slope no. 6SE-B/DT15, Shing Mun Catchwater, Tsuen Wan. The failure volume was about 1000m<sup>3</sup> and approximately 15m catchwater was broken with water pouring down about 20m to the bottom of backscarp. Record photos of landslide are shown in Plate 1 and 2. No development or facilities were affected as a result of the landslide. Immediate remedial works including diversion of the flow from upstream side, laying of DI pipes along the broken catchwater, shotcreting the bare slope surface, sealing all observed cracks in the vicinity of failure areas, backfilling of no-fines concrete, construction of gabion structures for earth-retaining structure and installation of soil nails were proposed. Schematic arrangement of remedial works is shown in Figure 3. Based on the investigation result, the cause of the failure was possibly due to prolonged heavy rainfall to build up a high groundwater table and leakage from catchwater to the downhill side which led to the destruction of a section of catchwater by deep-seated slope failure.

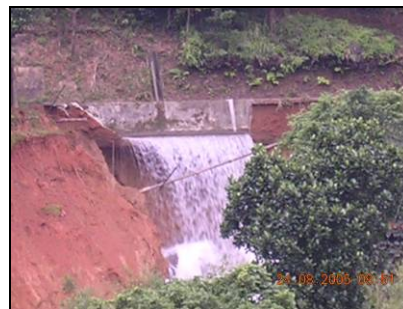
Plate 2: Water scouring out the downslope area

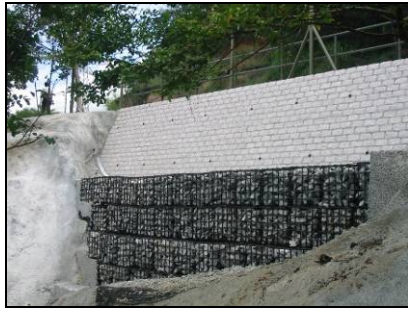
Plate 3: As-constructed remedial works

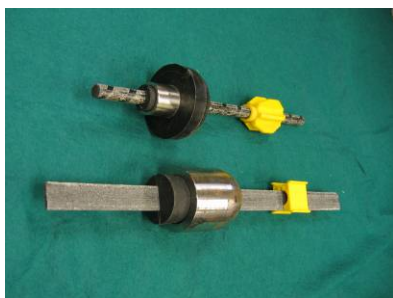
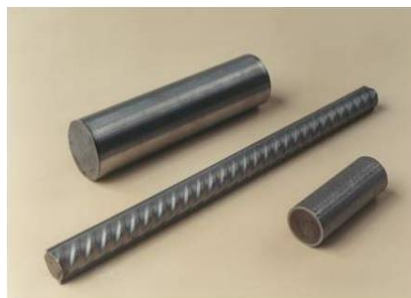
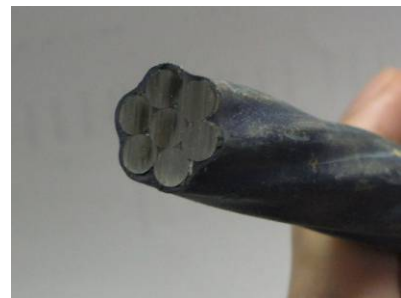
Figure 2: Nail reinforcement: (a) CFRP reinforcement, (b) solid stainless steel/stainless steel cladding bars, and (c) steel strand steel bar

A range of stainless alloy types is available for the selection of soil nail reinforcement. An advantage of stainless steel reinforcement is its high corrosion resistance while the ductile behavior of steel is retained. Apart from solid stainless steel bars, a hybrid of high yield deformed steel and stainless steel bars is also available in which the deformed steel bars are fused by a stainless steel cladding (Figure 2b). The cost of this material is, however, high and there is little experience in the use of this stainless steel cladding bars in soil nailing works. Nevertheless, it was established that solid stainless steel and stainless steel cladding bars of grade 304 or above are technically suitable for use in soil nailing works (AECOM, 2009).

High tensile steel strand reinforcement is commonly used in prestressed ground anchors (Figure 2c). Because of its flexibility, it is most suitable for use at sites with limited working space. In order to assess the suitability of using this material as soil nails, numerical analysis and field tests were carried out to examine the slacking effect of steel strands. Although the review suggests that the material may be suitable for use in soil nailing, it is susceptible to corrosion and suitable corrosion protection measures have to be provided. Details of the review can be found in CMW (2008).

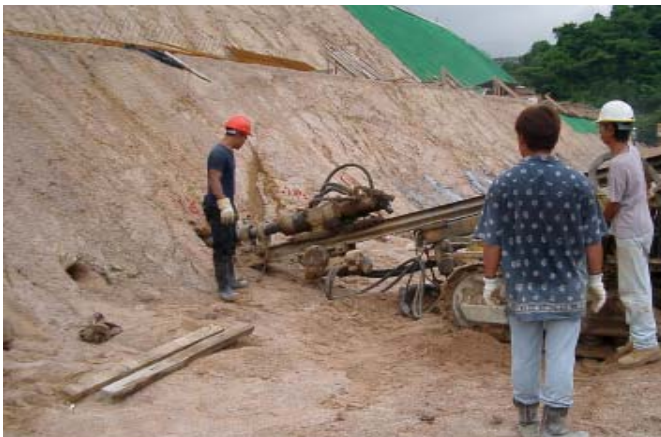
Plate 1: Use of mini-pile drilling rig for soil nail construction

Soil nails were initially constructed by crawler type mini-pile drilling rigs which were pneumatic percussive drilling rigs powered by air compressors (Plate 1). Due to the large-size of the machine, it could only be used in site formation projects with the ground in front being lowered in stages, or in roadside slopes with only one to two rows of soil nails. For large and steep slopes, construction of soil nails at height by mini-pile drilling rigs requires the construction of heavy duty access and working platforms. Bamboo or wooden scaffoldings (Plate 2) were the common practice but sometimes these scaffoldings may not be strong enough to support the weight of the machine. For obvious operational reasons, a simplified light-weight drilling rig with only a rotary motor mounted onto a fixed leader, powered by an air compressor placed at a convenient location, was devised subsequently (Plate 3). Air flush is used in all cases and the holes are drilled without casing. Because of its light weight, this drilling machine could be mobilised and handled by two workers only. The drilling machine can be supported by standard tubular steel scaffoldings (Plate 4) without the need of substantial access and working platform.

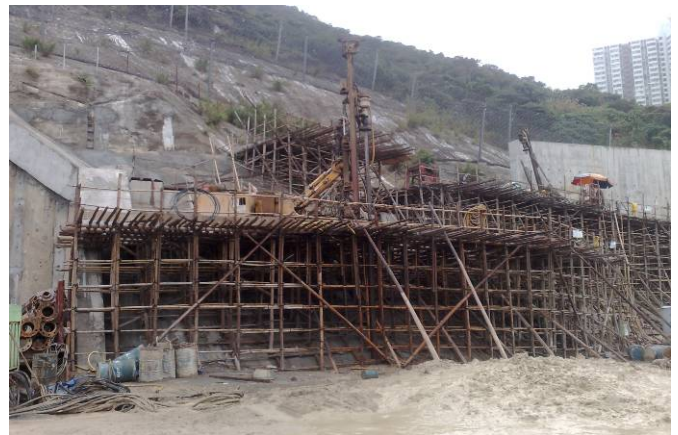
Plate 2: Bamboo scaffolding for mini-pile drilling rig

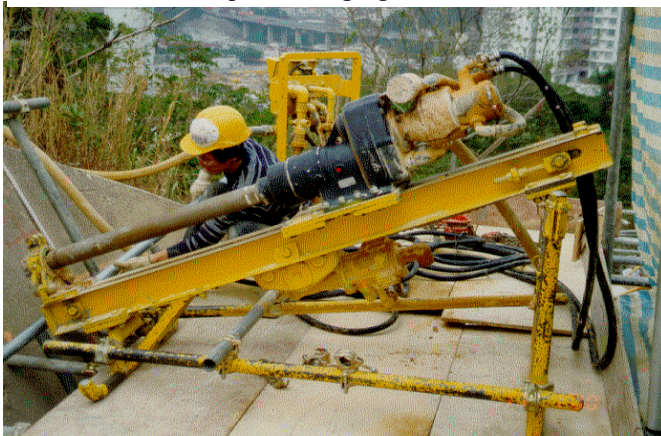
Plate 3 – Typical soil nail drilling rig with 1.5 m long leader

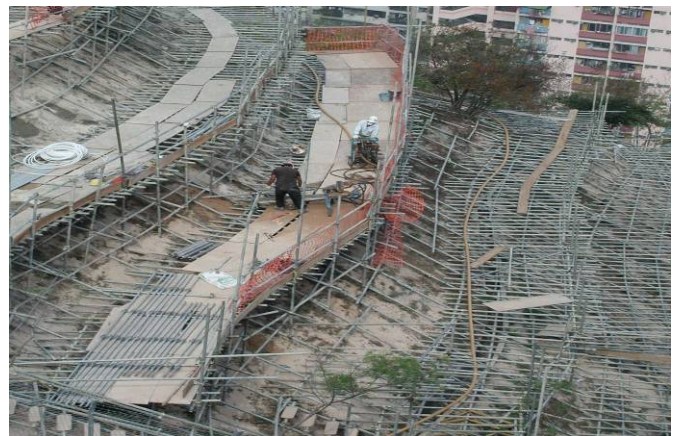
Plate 4: Steel tubular scaffolding for soil nail construction

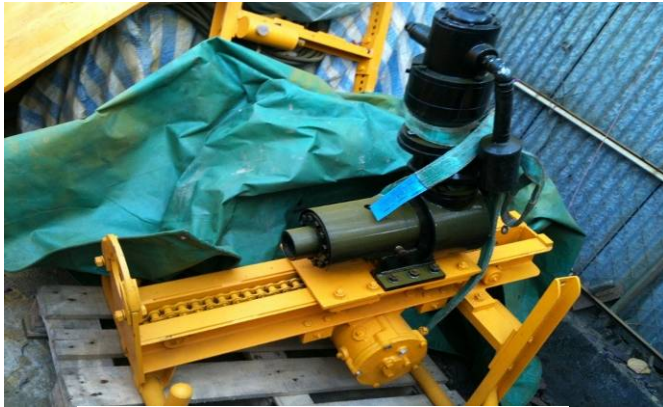
Plate 5: Special soil nail drilling rig with leader less than 1 m long

Many slopes affecting village houses, with very restrictive access and limited working space, are required to be upgraded. To cope with such conditions, an even shorter and tailor-made soil nail drilling machine was devised (Plate 5). Though continuous improvement in machinery has helped to overcome the difficult situation and site constraints, additional manpower is required to connect and fix drill rods of 500 mm long during the drilling operation. The effect is that as much as four times more working hours was needed for the drilling, fixing and installation of shorter soil nail bars, plus the additional materials cost (i.e. couplers and associated fixing accessories). Likewise, hand-held coring machines can be used for these kinds of slope works with limited space. Coring machines generate less noise and dust than their percussive counterparts, but the speed of coring is very slow and the maximum depth of coring is about 6 m only. The use of water as the flushing medium during drilling may also have adverse effect on slope stability.

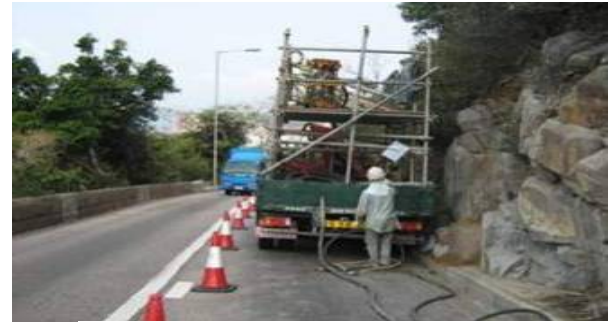
Plate 6: Drill rig on Lorry

The upgrading of some roadside slopes using soil nails posed another problem. For busy roads, application for lane closures for an extended period of time is often rejected by the relevant authorities. Permission for lane closure is restricted to a few hours each day, normally from 10:00 am to 3:00 pm. Since the drilling machine has to be demobilized for road opening on a daily basis, it is not possible to erect scaffoldings and working platforms for the set up of drilling machines in the usual manner. Under such circumstances, a tailor-made movable drilling system, by mounting of a drilling rig onto a lorry (Plate 6), has been developed to overcome this constraint.

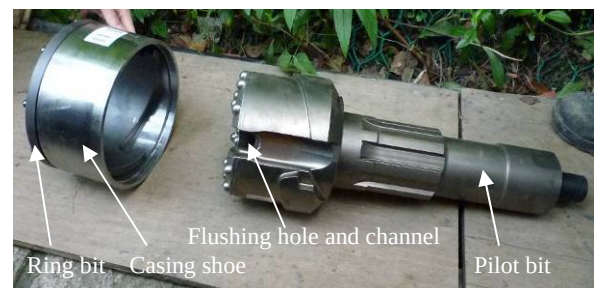
Plate 7: Ring bit and pilot bit of the concentric drilling system

and Plate 7). It does not have any eccentric parts and works with a pilot bit system together with a crown/ring bit. With the ring bit fully covering the pilot bit and guiding the air to return inside the casing, disturbance of the surrounding ground is minimized. Without the excessive torque on other parts of the drilling rig as compared to the ODS, the concentric drilling system has proved to work well in difficult grounds (e.g. very loose/boulder field/debris-fill slopes, etc). The main drawback is that the ring bit together with the casing shoe is welded to the permanent casing, which has to be left underground when the pilot bit and down-the-hole hammer are retrieved. A longer leader of about 2.5 m length has to be used to accommodate the pilot bit system and a higher air pressure, up to about 17 bars, is also required.

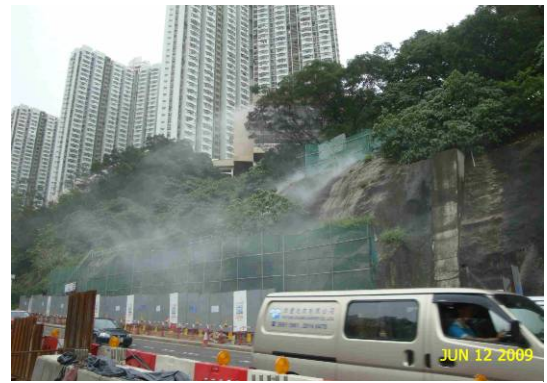
Plate 8: Dust coming out even with the use of tarpaulin sheet and water spraying

Another area of improvement that has been recently implemented to address the conventional problem of dust generated by soil nailing works is the promulgation of air blower. Conventionally, dust suppression was done by spraying water and covering the surrounding area of the drilling rig by tarpaulin sheets. However, this may not be effective especially during drilling in rock (Plate 8) and spraying water constantly onto a slope might have adverse effect on slope stability. Recently, a new system comprising a portable air blower connected to a duct has been used. One end of the duct sucks the dust generated from the drilling rig while the other end discharges the dust into a bucket of water. The driving force of the suction/blowing action comes from the air blower connected in the middle of the duct (Plate 9). The whole system can be reused and hence is environmentally friendly. This is also a cost-effective solution and reduces complaints regarding dust generated by soil nailing works. This preferred means to reduce dust generation would be adopted in all future LPM works.

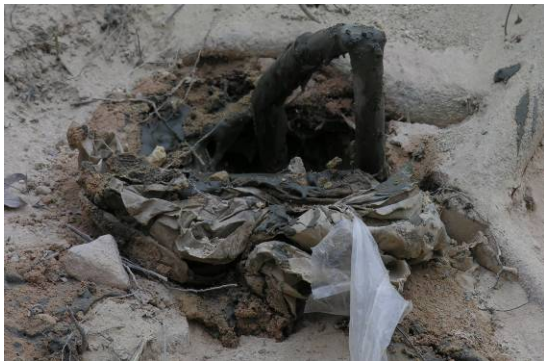
Plate 10: Top of drillhole plugged with cement package bags

Before the introduction of the “L-shaped” upstand pipe, a sub-horizontal soil nail could never be fully filled with cement grout in liquid state without something plugged at the top of a drillhole. It was therefore a common practice to use empty cement bags to plug the top of a drillhole as the hole was deemed to be fully filled in the first instance, and then poured grout back to the empty space on the next day (Plates 10 and 11). In order to ensure full grouting of the drillhole, a slight pressure grouting method using a 300 mm long “L-shaped” upstand pipe was introduced in early 2004 (Plate 12). This upstand pipe also serves as a monitoring device to check the quality of overflow grout. Grouting operation shall only stop when the overflow grout is consistent and free of undesirable substances. As an additional control measure, samples of overflow grout may be taken for examination of its consistency and quality and reconfirmation of its workability as necessary. When grout injection stops, the grout level in the upstand pipe may drop as some grout in the hole is lost to the surrounding ground. The upstand pipe would be refilled with grout to keep up the pressure whenever the grout level in the upstand pipe drops to the bottom of the bend.

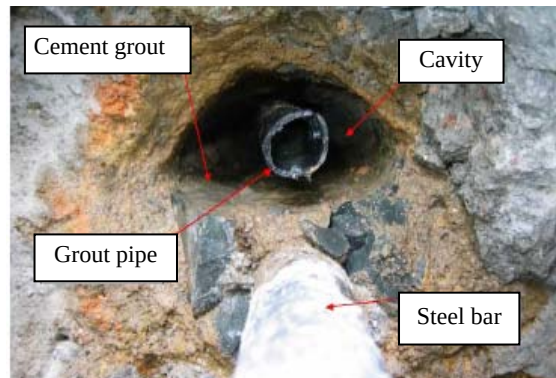
Plate 11: Absence of grout on the upper part of drillhole

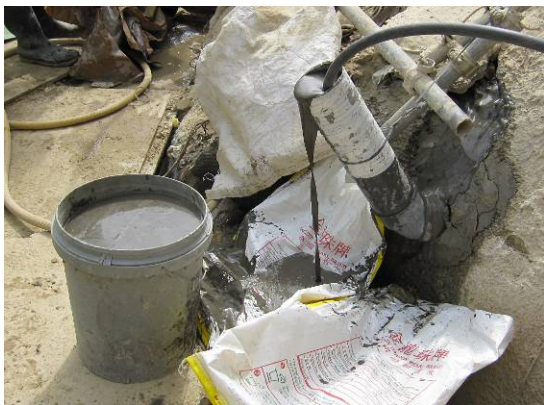
Plate 12: Use of “L-shaped” upstand pipe for maintaining grout level

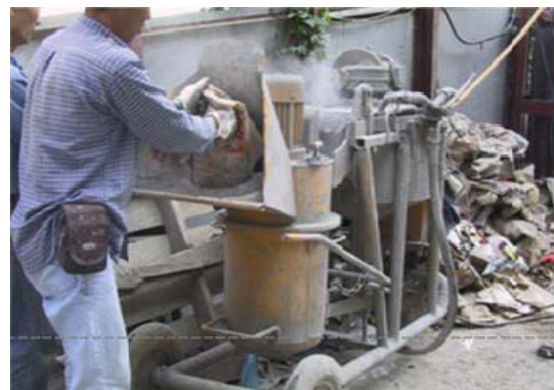
Plate 13: Smaller grouting equipment used for LPM site

In addition to the system improvements and control measures introduced to the grouting process over the years, the grouting equipment has become smaller and more compact (Plate 13). Traditionally, the mixer (1.2 m diameter), the grout storage tank (1.2 m diameter) and hydraulic pump (1.5 m x 0.5 m) are separate items and require a much larger area (3 m x 3 m) for their accommodation. The newer all-in-one grouting equipment, with mixer, agitation tank and grout pump, can be lifted and placed easily within a small area of about 1 m x 2 m.

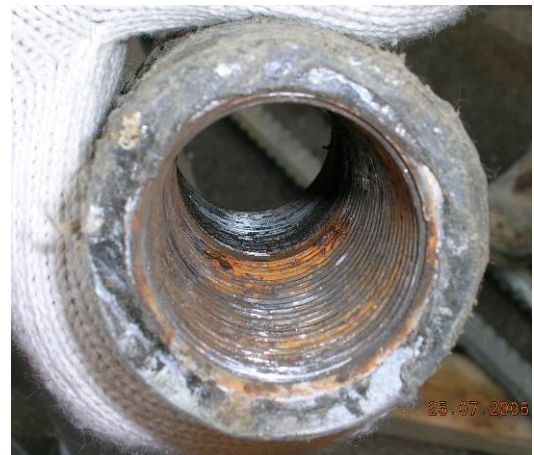
Plate 15: Rust formed in coupler

For those sites with limited space, steel bars will be cut into shorter pieces and connected by couplers to facilitate installation of soil nails. The threaded ends of these steel bars and the couplers are more vulnerable to corrosion as threading is carried out after hot dip galvanization of the steel bars. As a standard practice, zinc rich paint is applied directly to the threaded portion of steel bars and couplers. However, the level of protection provided by the paint is less than that of hot dip galvanization, as rusts were often found at the threads on the steel bars and couplers during site inspections (Plate 15). It is

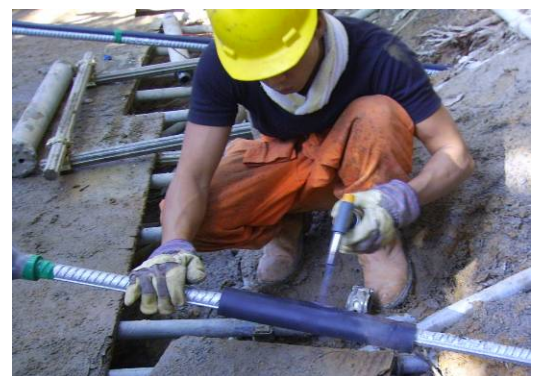
Plate 16: Use of hand-held blower to apply the heat-shrinkable mastic material onto the soil nail steel bar

As an additional precautionary measure, heat-shrinkable mastic sleeve was introduced in 2003 to further reduce the possibility of rust development in the coupler portion, the weakest link in the system against corrosion. Heat-shrinkable mastic material can be applied easily on the coupler portion on site by heating with portable gas equipment (Plate 16). The inner mastic sealant material will then tightly encase the steel bar and inhibit corrosion by preventing air and water from getting inside.

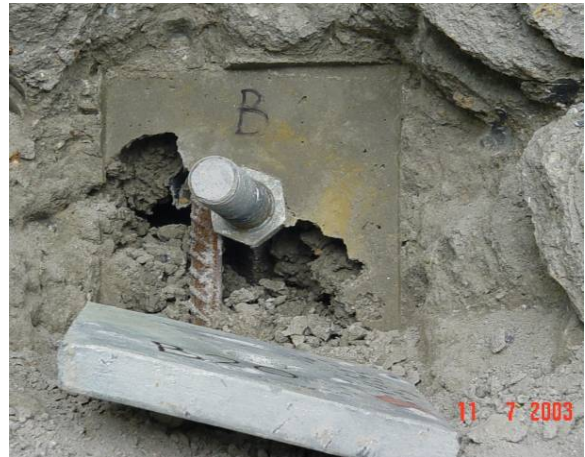
Plate 17: Voids observed below the bearing plate

Particular attention should be paid to ensuring the integrity of soil nail heads, especially at the location beneath the bearing plate where honeycombing is not uncommon. For nail heads to be constructed using shotcrete, it is a good practice to construct the nail head in two stages. In the first stage, shotcrete should be applied to a specified thickness above the intended base level of the steel bearing plate. The bearing plate should then be hammered into place to ensure that no void is left behind, and the nut tightened onto the soil nail reinforcement before application of the second stage shotcreting. Despite the common knowledge of this good practice, there are findings of honeycombing and/or voids underneath the bearing plate in audits from time to time (Plate 17). This reflects the fact that proper construction practice on site and adequate supervision should never be overlooked.

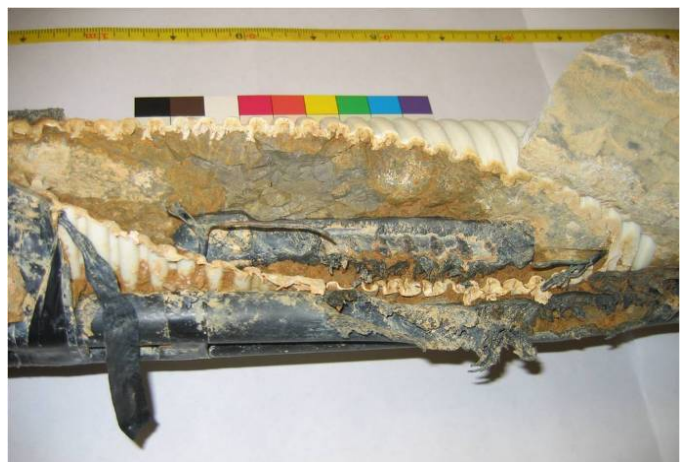
Plate 18: Doubtful grout integrity detected in completed nail

successfully detected some cases where grout integrity was in doubt. Subsequent investigation revealed that the cement grout sleeve was damaged by the drilling of a nearby raking drain (Plate 18). The use of TDR to spot check the length of soil nails installed and grout integrity has become a standard practice for LPM sites.

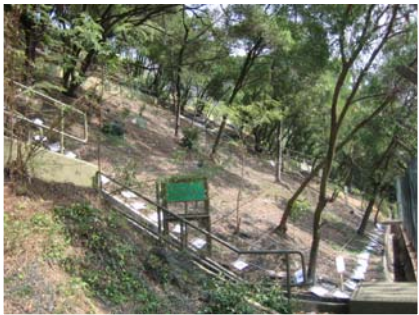
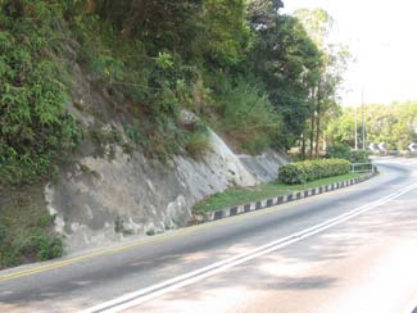
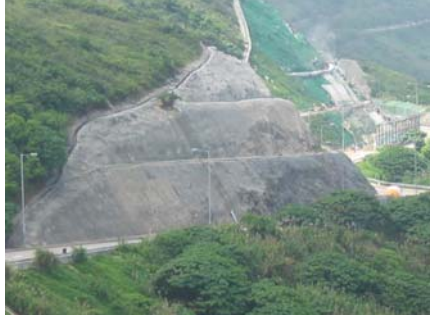
| Slope 10NE-B/C77<br>Tsing Nam Street, Tsing Yi | Slope 11NE-B/C824<br>Clear Water Bay Road | Slope 12SW-A/C129<br>Tai Au Mun Road |
|---|---|---|
| <ul style="list-style-type: none"> <li>• Slope gradient 40 deg</li> <li>• South facing</li> <li>• The slope surface is almost entirely covered by &gt;7m tall mature <i>Acacia confusa</i> trees</li> <li>• This is not a roadside slope</li> <li>• Low sunlight illumination because of the tree canopy</li> </ul> | <ul style="list-style-type: none"> <li>• Slope gradient 50 deg</li> <li>• Northwest facing</li> <li>• Hard surface cover before LPM works</li> <li>• No existing trees on slope surface</li> <li>• Mature trees on the slope crest provided appropriate shade for the slope surface</li> <li>• Relatively high traffic flow at slope toe</li> </ul> | <ul style="list-style-type: none"> <li>• Slope gradient 55 deg</li> <li>• East facing</li> <li>• Hard surface cover before LPM works</li> <li>• No existing trees on slope surface</li> <li>• Directly exposed to the sea, therefore receive strong wind and sun light illumination</li> </ul> |

Figure 1: Characteristics of the three slopes in the trial

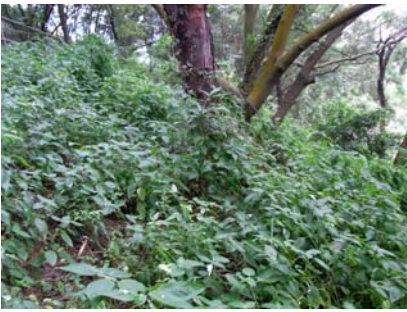
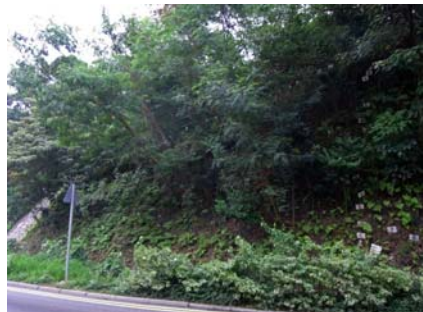
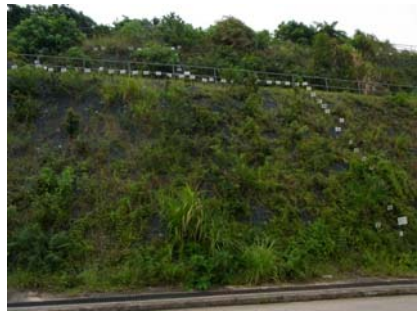
| Slope 10NE-B/C77<br>Tsing Nam Street, Tsing Yi | Slope 11NE-B/C824<br>Clear Water Bay Road | Slope 12SW-A/C129<br>Tai Au Mun Road |
|---|---|---|
| Plot 1 and Plot 2 was invaded by weeds and had low seedling survival. | A 3-4m canopy was formed | Seedling growth was slow and no canopy was formed on all three plots. |

Figure 2: Plant establishment on the three slopes 5 years after planting

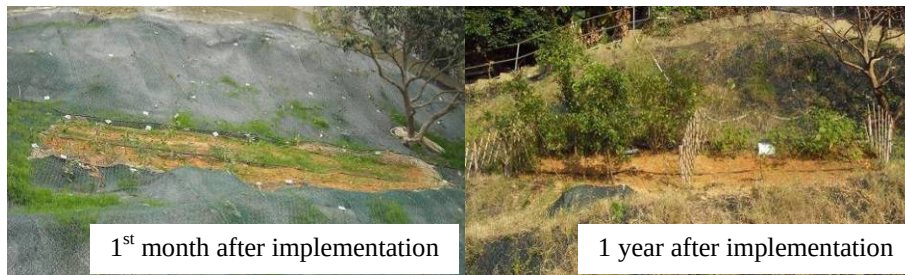
Plate 2: 6SE-B/C92 (Site B) - Hedgelayers

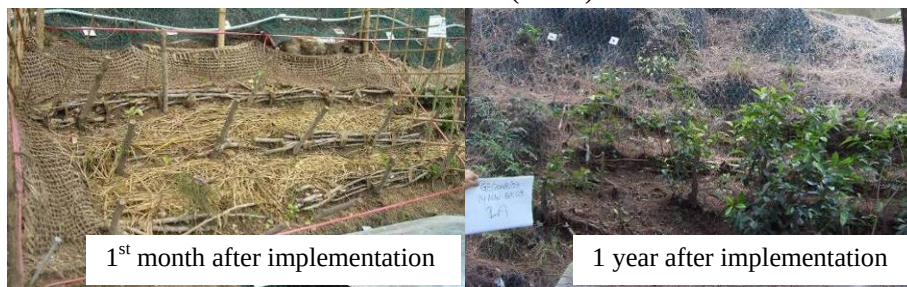
Plate 4: 14NW-A/C129 (Site D) - Live Fascines

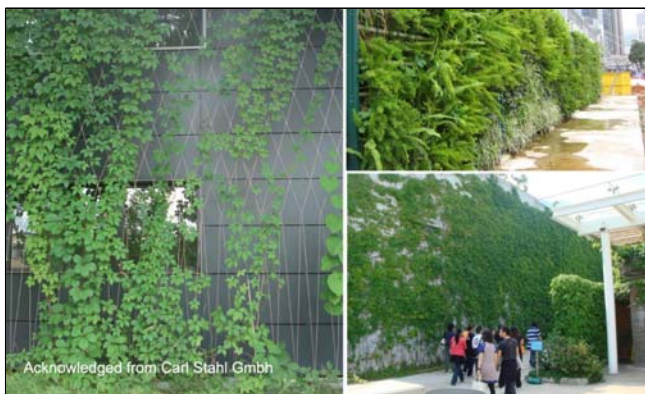
Figure 9: Greening on vertical wall

The vertical facade of the check dams would be one of the key visual concerns that needs to be addressed. A number of greening proposals on vertical surface were proposed (see Figure 9). Traditional self-clinging climbers on concrete structure would provide satisfactory greening effect. However, there would be a limited choice of climber species. Climbers on wire mesh were proposed to explore more species diversity for the check dams. In addition, proprietary vertical green panels which can provide instant landscape effect were proposed to one of the check dams as a pilot scheme.

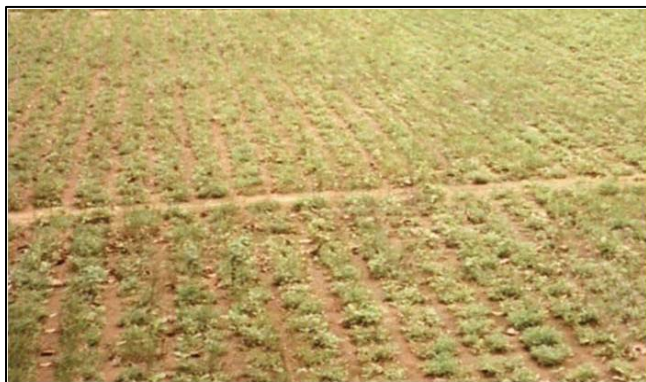
Figure 11: Traditional Grasscrete surface

Because the location of the NTHMW is near the Hong Kong International Airport, there would be many air flight passengers who can see the check dams from aircrafts. The appearance of the base slabs of the check dams should be carefully addressed (see Figure 11). Traditional grasscrete was proposed. In addition, Grass Block in High-density polyethylene (HDPE) as a pilot scheme was also proposed to provide greening on the base slabs.

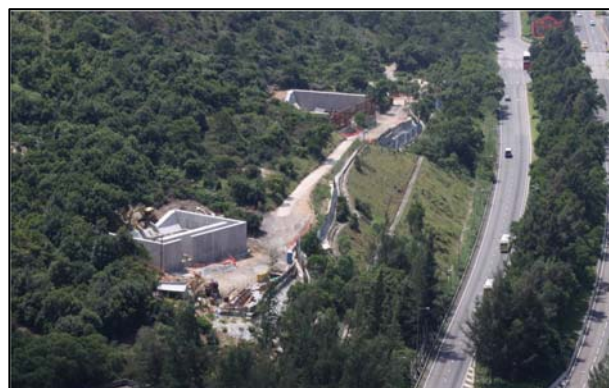
Figure 13: Existing condition during construction

Photomontages have been prepared to illustrate the existing condition during construction (See Figure 13), the intended landscape effect at the end of establishment period (see Figure 14) and the landscape effect when planting become mature (see Figure 15). It is considered that even with the colour treatment and planting proposed for the concrete check dam, there would still be some landscape and visual impact upon completion of the landscaping works. However, when the buffer planting and climbers become mature, the impact due to the NTHMW would become negligible.

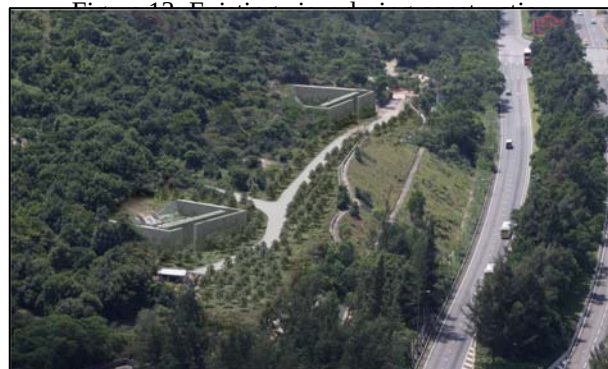
Figure 14: After completion of landscape works

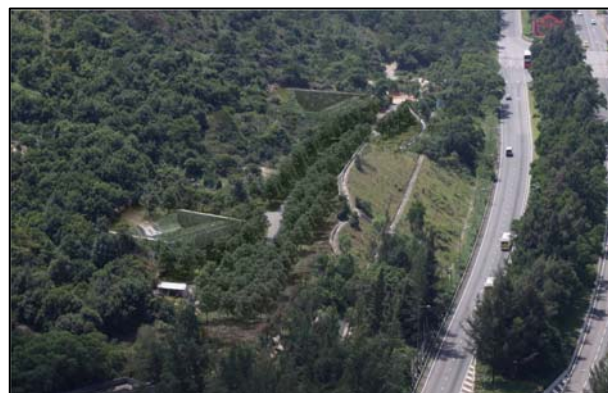
Figure 15: Effect when planting matured

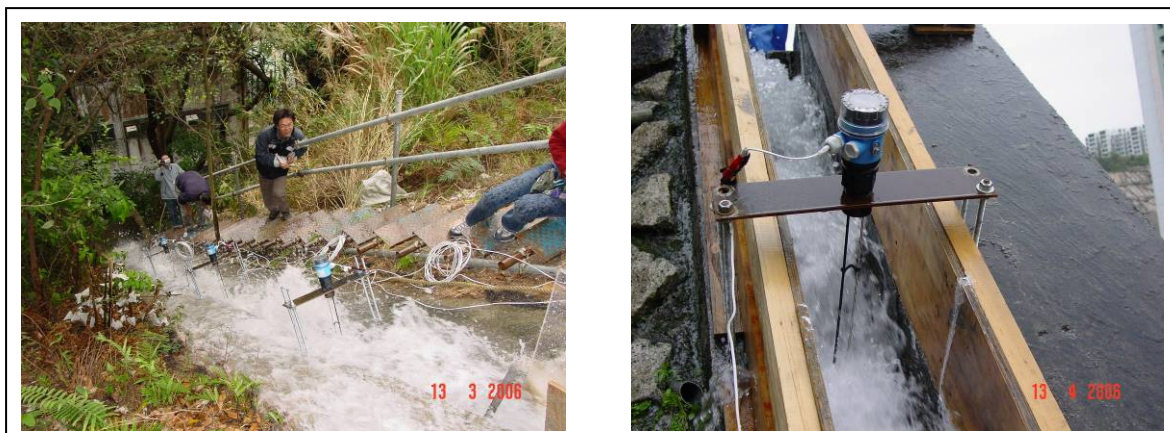
Figure 1: Field test of stepped drainage channel

Field tests were carried out at four sites on Hong Kong Island (Bowen Road, Mount Davis Reservoir, Yiu Hing Road and Chai Wan North FWS Reservoir) between March and June 2006 to verify the design assumptions (Figure 1). The tests showed good agreement between the observed and design capacity using the improved design method. The improved design method was then promulgated through GEO Technical Guidance Note No. 27 (TGN 27) in 2006 (GEO, 2006). The recommendations given in TGN 27 have also been incorporated in the Stormwater Drainage Manual published by the Drainage Services Department.

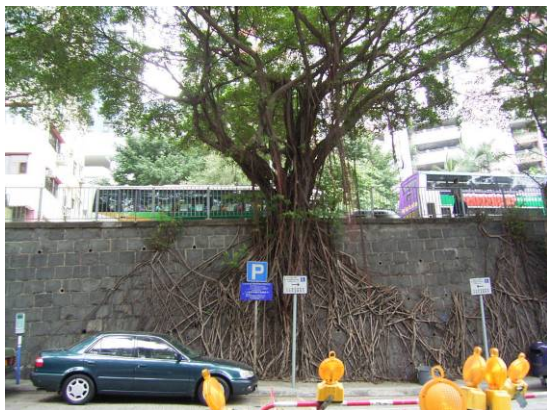
Figure 2: Study of old masonry walls with trees

During the urban development of Hong Kong in early days, it was common that masonry retaining walls were formed in association with the construction of houses and roads (Figure 2). Trees, in particular banyan trees, were often found growing spontaneously on these old masonry walls. The majority of these old masonry walls with trees are found in northern part of Hong Kong Island, especially in the Mid-Levels. As the old masonry walls with trees constitute an important and beautiful landscape element and heritage of urban Hong Kong, special efforts have been made to preserve the existing trees and masonry block patterns, without compromising on slope safety.

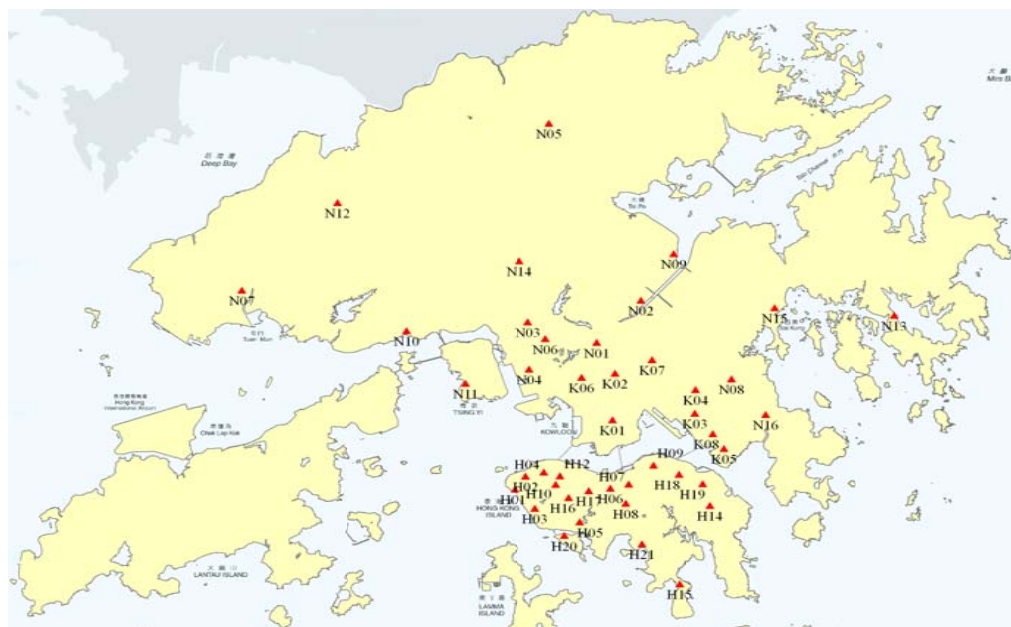
Figure 1: Locations of 43 GEO Raingauges with Some 26 Years of Rainfall Records

The GEO has been operating a network of automatic raingauges since 1984, which collect 5-minute rainfall data round the clock. The system comprises 86 GEO raingauges installed over Hong Kong. A total of 43 GEO raingauges have collected some 26 years of records. The locations of these raingauges are shown in Figure 1. Frequency analysis was carried out to determine the extreme rainfall intensity based on the available data.

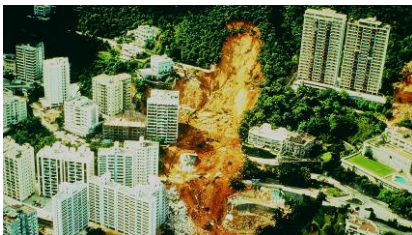
Plate 1: The June 1972 Po Shan Road landslide (67 fatalities)

Hong Kong is unique in terms of its combination of high seasonal rainfall, steep terrain in close proximity to dense urban development and a large stock of potentially substandard man-made slopes. Following a number of landslide disasters in the 1970's that caused more than 150 fatalities (Plates 1 to 3), the Geotechnical Control Office (renamed the Geotechnical Engineering Office (GEO) in 1991) was set up in 1977 to tackle the acute slope safety problem and launched the LPMP to deal with existing high-risk substandard slopes formed without geotechnical input. Under the LPMP, substandard Government slopes affecting major roads and developments were upgraded, in addition to conducting safety-screening studies for private slopes, in a risk-based priority order. The LPMP has substantially reduced the overall landslide risk posed by man-made slopes.

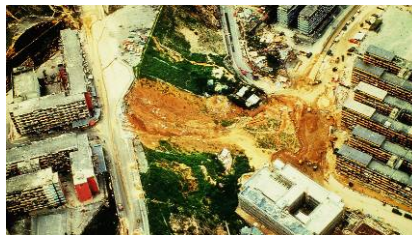
Plate 2: The June 1972 Sau Mau Ping landslide (71 fatalities)

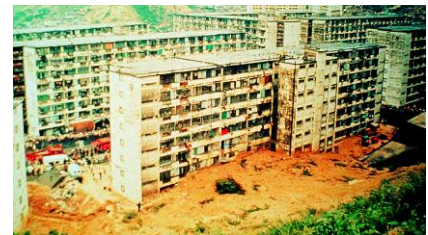
Plate 3: The August 1976 Sau Mau Ping landslide (18 fatalities)

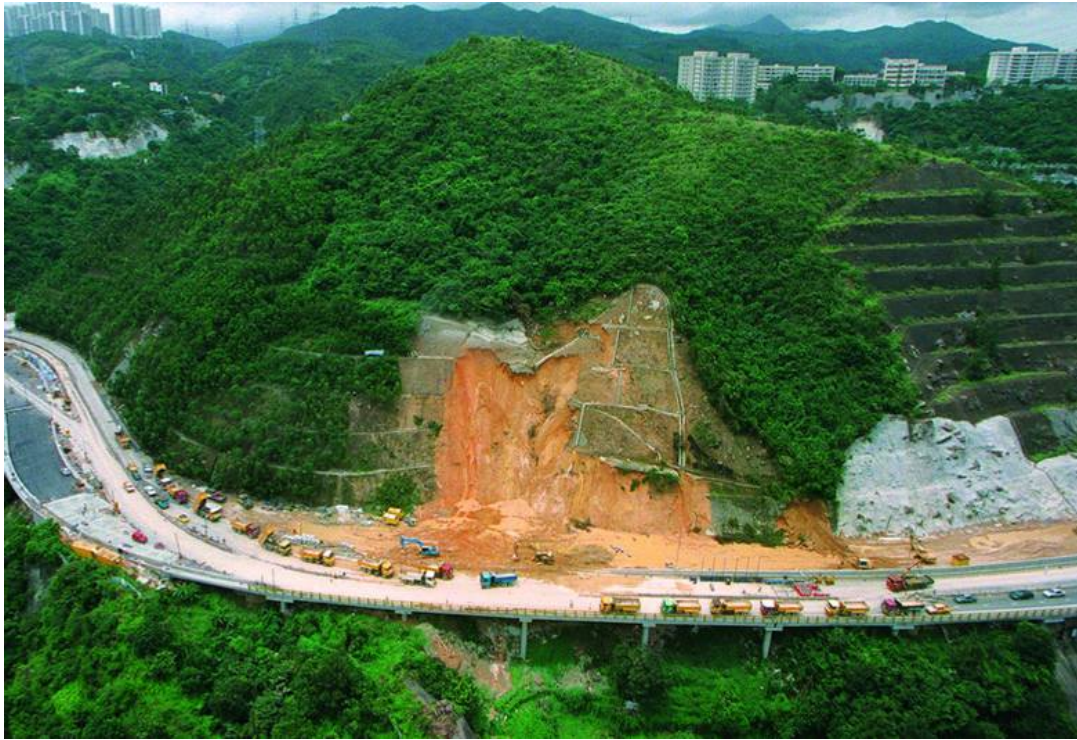
Plate 4: The Ching Cheung Road landslide in August 1997

In July and August 1997, three successive failures occurred on an unsupported soil cut slope above Ching Cheung Road, which is a major urban trunk road connecting east and west Kowloon. The slope was upgraded under the LPMP between 1990 and 1992. The first two failures occurred in July 1997, which culminated in the major failure on 3 August 1997 (Plate 4). The scales of the failures were  $500 \text{ m}^3$ ,  $700 \text{ m}^3$  and  $2,000 \text{ m}^3$  respectively. The August 1997 landslide completely blocked a 50 m section of the road and trapped a vehicle, fortunately with no casualties. The trunk road was subsequently closed for about one month until completion of temporary slope stabilisation works.

instabilities probably resulted in local weakening of the groundmass and contributed to the development of the extensive system of erosion pipes in the slope. The detailed investigation (HAPL 1998) established that the landslides were probably caused by the build-up of adverse transient groundwater pressure, following severe rainfall in early July 1997 and the preceding months. The failures occurred at the location of a buried drainage line below a sizeable upslope catchment where concentrated groundwater flow was likely to have resulted in higher groundwater levels than that of the surrounding area.

This landslide illustrates the vulnerability of unsupported soil cuts to undetected weaknesses in the groundmass. In the light of this, slopes previously upgraded under the LPMP or other public works projects involving unsupported soil cuts will be dealt with, in accordance with a risk-based priority ranking, under the Landslip Prevention and Mitigation Programme (LPMitP), which was launched in 2010 to dovetail with the LPMP.

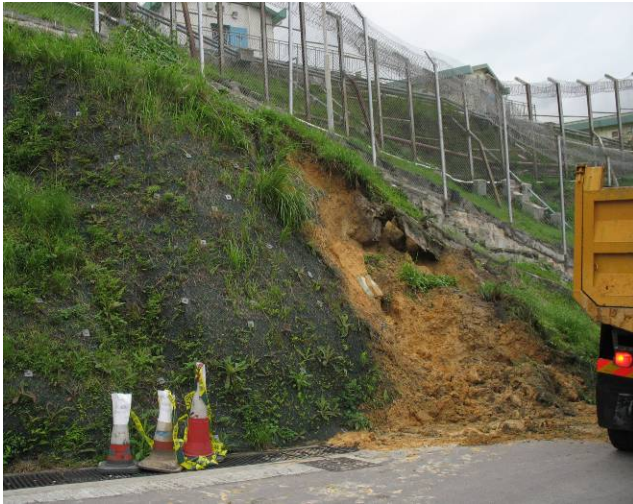
Plate 5: Minor failure (10 m<sup>3</sup>) at Tai Lam Correctional Institution in 2009

Since the 1990's, soil nailing technique has been widely adopted for upgrading existing substandard soil cut slopes under the LPMP. The use of soil nails is considered to be a robust solution in that it can accommodate local weaknesses in the groundmass through stress redistribution and hence is less vulnerable than unsupported cuts to undetected adverse ground conditions. A soil-nailed cut slope effectively behaves as an integral mass, exhibiting a ductile mode of failure. This would provide some prior warning of impending failure through the progressive development of slope distress as well as reduced debris mobility in the event of detachment. The promising performance of soil-nailed cut slopes under the LPMP is reflected in Table 1 in that no major failures have occurred on such slopes thus far. However, soil-nailed slopes are not immune to failures. Minor failures do occur from time to time (Table 1), mostly involving surface erosion or minor local detachment from the groundmass between soil nail heads (Plate 5). Potential for such minor failures may be reduced by improved detailing of the slope surface provisions and enhanced slope surface protection details (Ng et al. 2008).

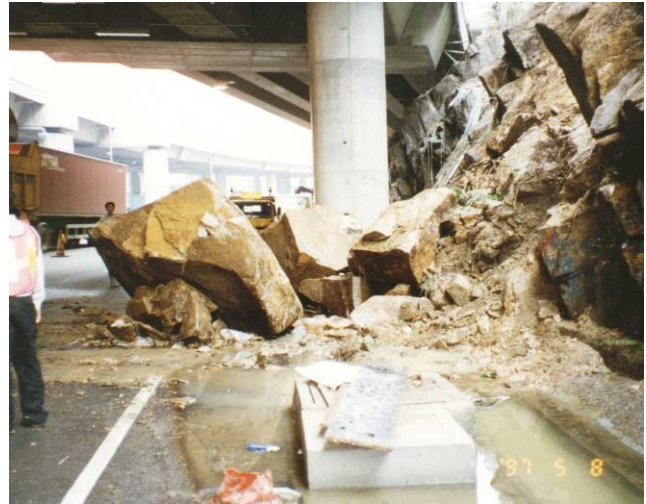
Plate 6: Relatively large detachment (23 m<sup>3</sup>) at Kwai Chung Road in 1997

Prescriptive measures for the stabilization of existing rock cut slopes have been widely adopted in Hong Kong for many years. Typical rock slope treatment works include rock dowels, concrete buttresses, dentition, rock mesh netting, etc. Between 1997 and 2010, there was no major failure. During this period, 18 minor failures occurred on rock cuts upgraded under the LPMP (Table 1). The majority of these failures involved minor rockfalls due to local adverse groundwater regimes and/or loosened or unstable blocks, many of which were initiated by tree root wedging action. Some involved relatively large detachment as observed in the 1997 Kwai Chung Road incident (Plate 6).

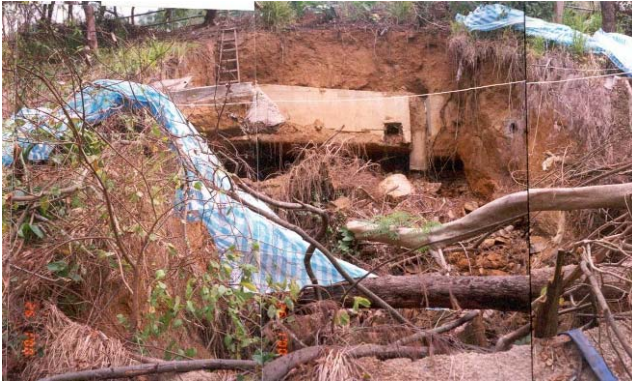
Plate 7: Major failure of a recompacted fill slope at Castle Peak Road in 2000

- (a) Leakage of water-carrying services could result in large-scale washout failures. In the period considered, there were two major failures due to leakage or bursting of water-carrying services, involving fill slopes upgraded by recompaction under the LPMP. The largest failure (700 m<sup>3</sup>) occurred at Castle Peak Road near Kau Wah Keng Village in 2000 (Plate 7).

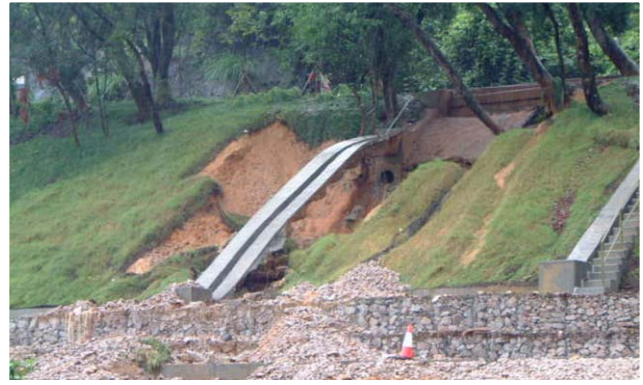
Plate 8: Failure of a compacted rockfill slope at South Lantau Road in 2003

- (b) Concentrated surface water flow due to inadequate surface drainage provision or detailing could also be a key contributory factor to major washout failures, as observed in the major failure of a recompacted fill slope at Waterfall Bay Park in 1999. Similar observation was also noted in a major washout failure on a compacted rockfill slope at South Lantau Road in 2003 (Plate 8). These landslides reflect more on the ineffective surface drainage system than the performance of the recompaction approach.

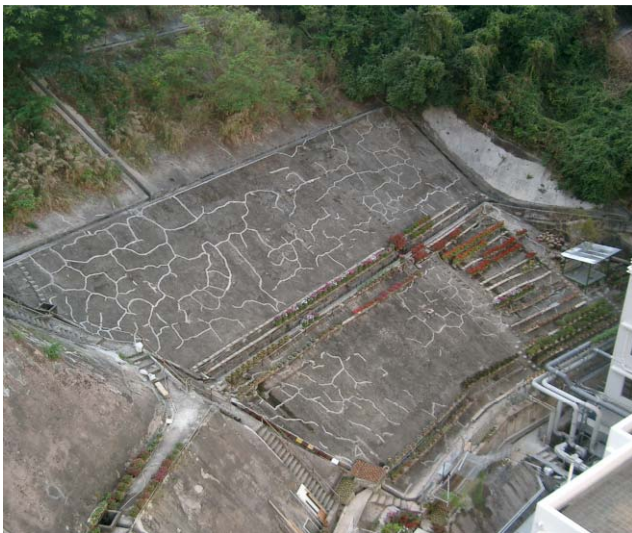
Plate 9: The distressed slope below Stubbs Road reported in 2004
